## **Evaluating the Impacts of Uncontrolled Air Flow and HVAC performance Problems on Florida's Commercial and Institutional Buildings**

### **Final Report**

**FSEC-CR-1210-00**

**October 31, 2000**

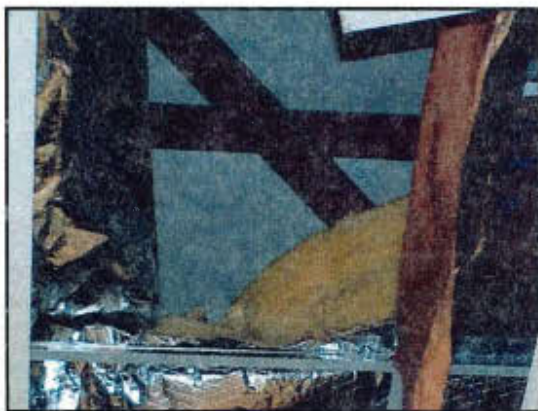
- Ceiling plane - consisting of a T-bar assembly, an air space of approximately 18 inches, a metal grid covered with a radiant barrier material, and an R-19 fiberglass battled insulation. The perimeter vertical (wall) section between the T-bar ceiling and the radiant barrier covered grid did not have a good air barrier in many areas of the building, especially above the bathrooms (Figures 4-7).

Figure 4. Missing air barrier & insulation that had been moved to gain access to attic

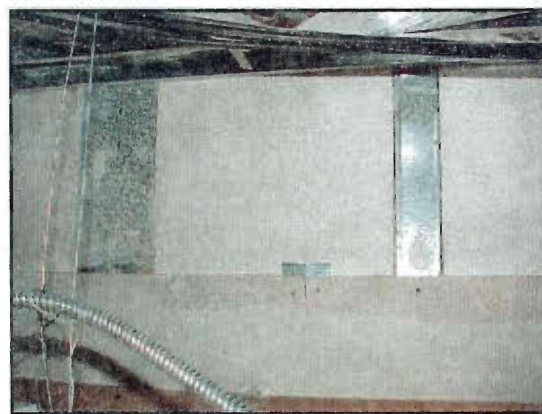
Figure 5. Incomplete air barrier at connection of wall assembly to ceiling

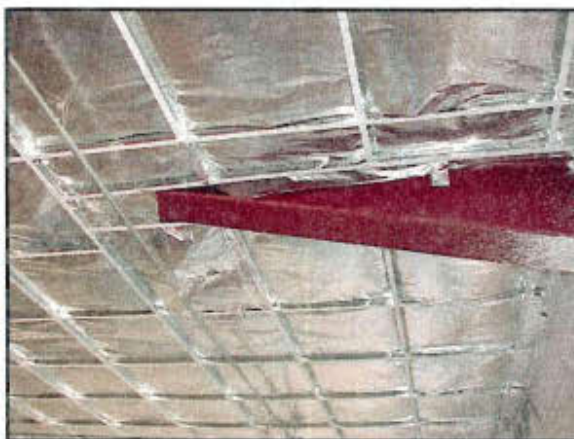
Figure 6. Metal grid system covered with radiant barrier acting as air barrier. Numerous gaps exist, especially at penetrations of the grid assembly.

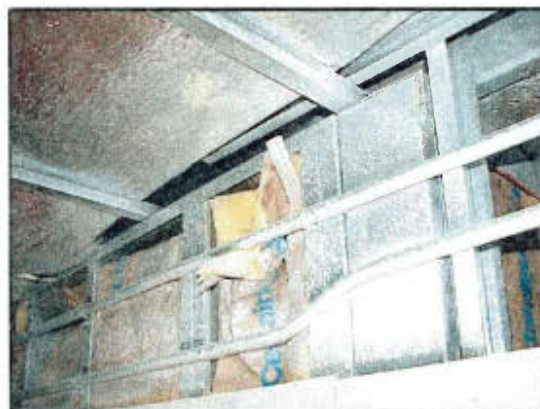
Figure 7. Incomplete air barrier over t-bar ceiling.

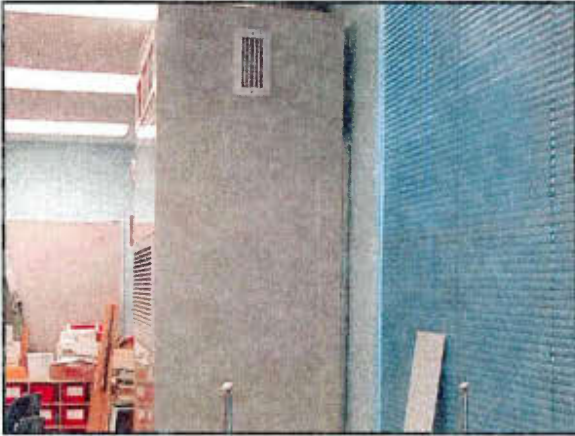
- PTHP assembly - the unit rolls on wheels and is slid into an opening (about the size of the PTHP unit) in the exterior wall of each classroom (Figures 8 and 9). There is large leakage between the unit and the wall opening. In general, the gap is 1 inch to 2 inches wide depending on the rough opening dimensions of the wall and closeness of the unit to the wall. There was no seal between the wall and unit.

Figure 8. The interior decorative trim has been removed to show the space between the unit and wall. This space is approximately 1 inch.

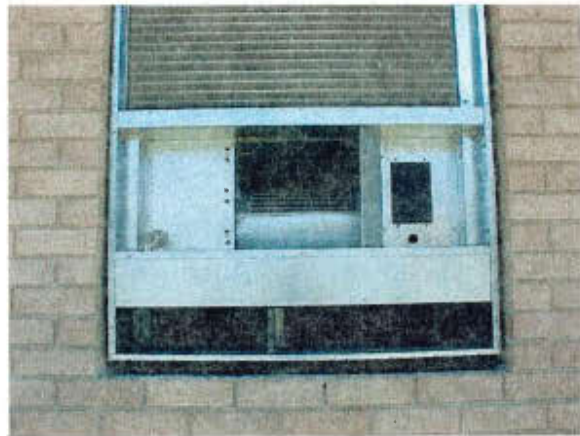
Figure 9. Exterior view of PTHP unit with grille assembly removed. Approximately 1 inch of clearance exists between the unit and the wall.

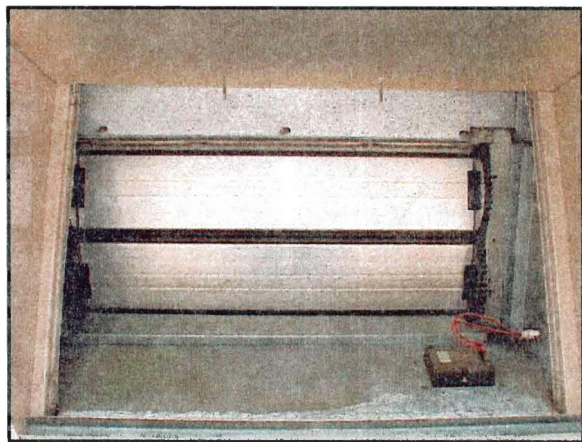
Figure 4. Economizer/outdoor air damper mostly closed.

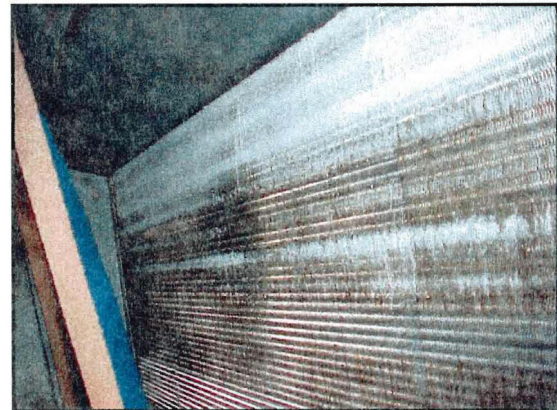
**Figure 5.** Deflection of filter and frost on coil can be seen.

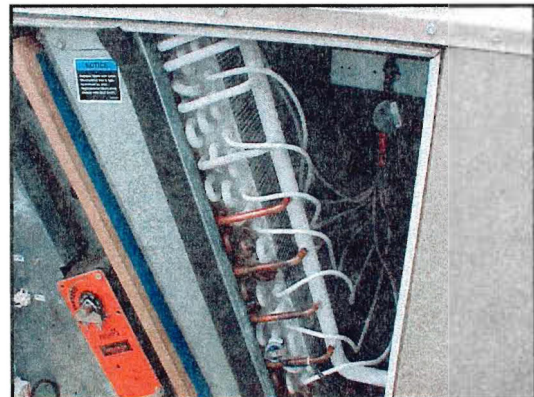
**Figure 6.** Frost on coil.

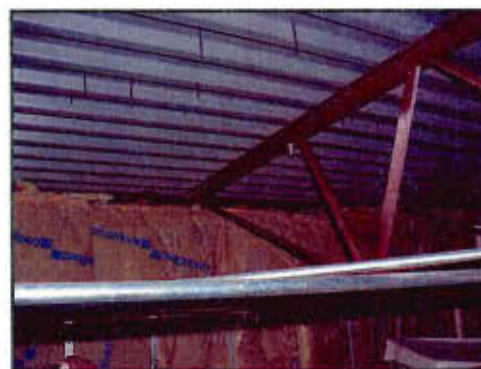
Figure 33. Ceiling space showing gap at roof deck to wall intersection.

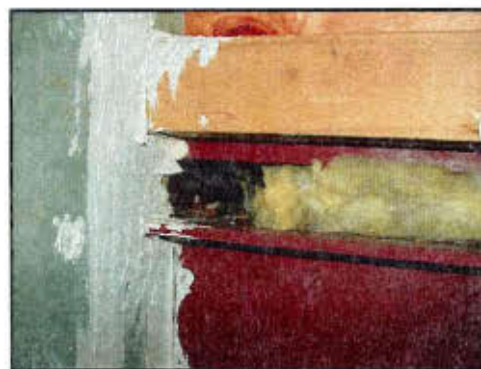
Figure 34. Gap above structural beam

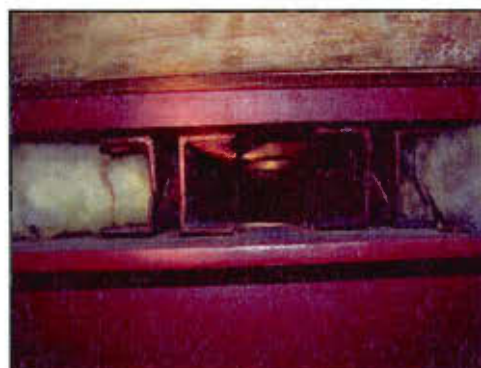
Figure 35. Air leak pathway where metal truss sits on top of structural beams.

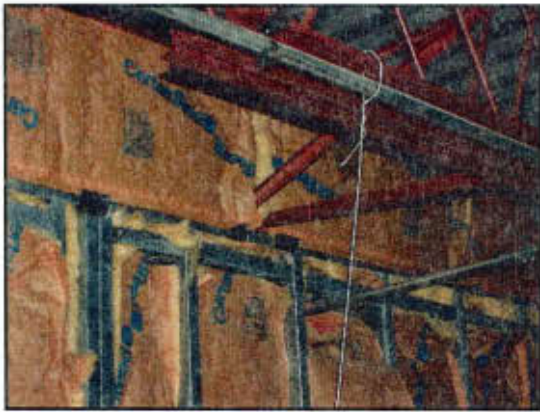
Above the suspended ceiling, insulation batts are partially held in place against the plywood exterior sheathing and the beams by duct tape (Figure 36). In some areas, the batts are falling off (Figure 37). The roof thermal system has some deficiencies. The white roof is an excellent feature, helping to shed much of the solar radiation. However, portions of the roof are stained by grease and dirt and are therefore considerably hotter than they otherwise would be. Cleaning will make the roof more energy efficient. The insulation in the roof system is apparently only 1 inch in thickness, so considerable heat can pass through. Also, air can flow freely in the corrugated grooves just below the insulation and just above the roof deck, and in some cases the hot air in these grooves is drawn in through openings around roof curbs by the building depressurization.

Figure 36. Wall insulation above ceiling

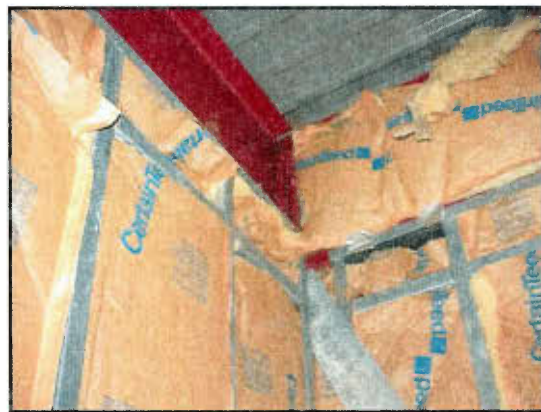
Figure 37. Insulation fallen from beam.

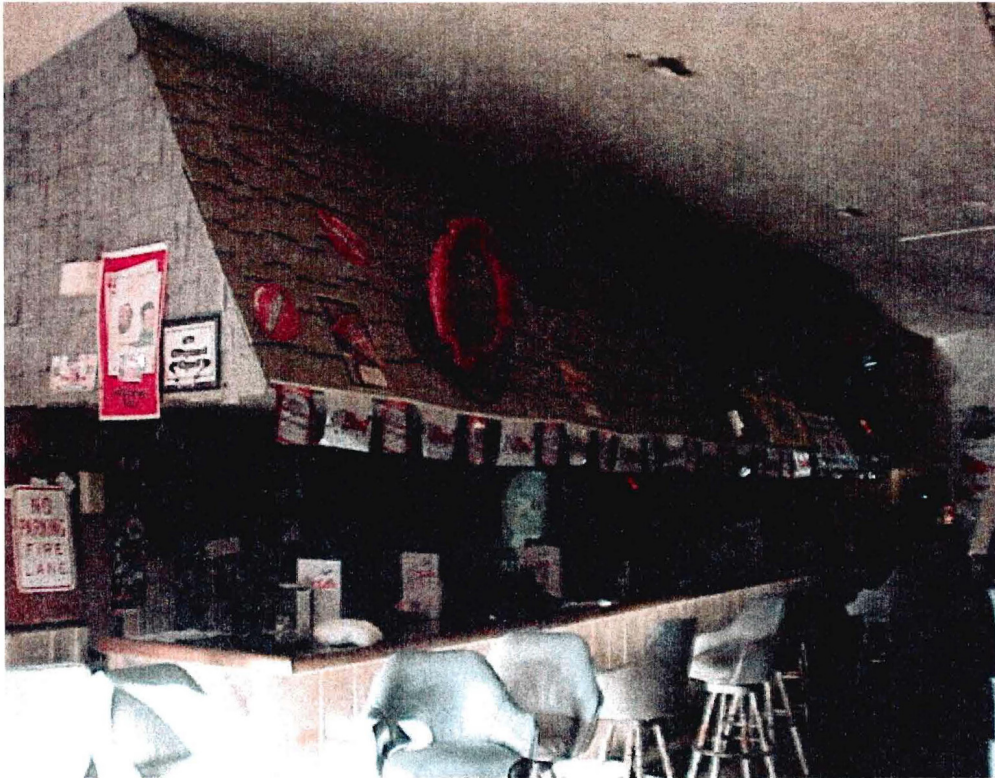
Major air leakage pathways were identified from the south side of the attic into the building. Air tightening and insulating the area over the bar (Figure 3) would have been difficult and time consuming due to many obstructions and there were many recessed lighting fixtures in this area that could not be air tightened or insulated for safety reasons. The bar runs east to west with the south attic section directly above and behind it. The kitchen area is behind the bar and has a horizontal drywall ceiling 8 feet above the floor.

**Figure 3** Ceiling over bar area was very leaky and poorly insulated.

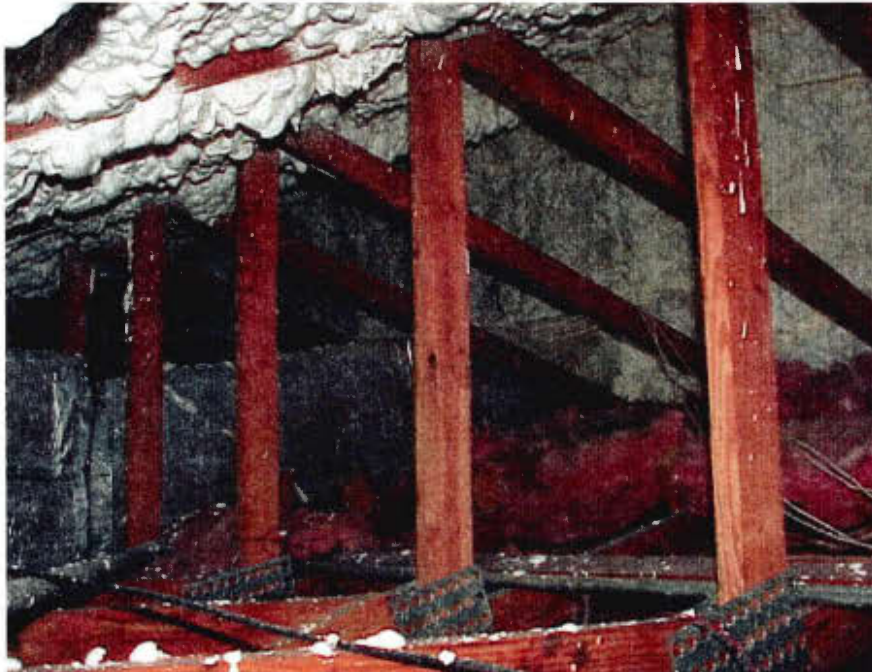
In Figure 4, the vertical section is the constructed wall in the middle of the attic that separates the north and south sides. The supply duct is on the west air conditioner system and runs from the air handler (not in picture) on the left side to the north side attic where it branches off to the supply registers. Large voids in batt insulation can be seen in the bottom of the picture. Overall the insulation ranged in depth from about 4- 8 inches thick, with average depth of about 4½ inches.

**Figure 4.** View of attic air / thermal retrofit with void in original batt insulation shown at the bottom of picture.

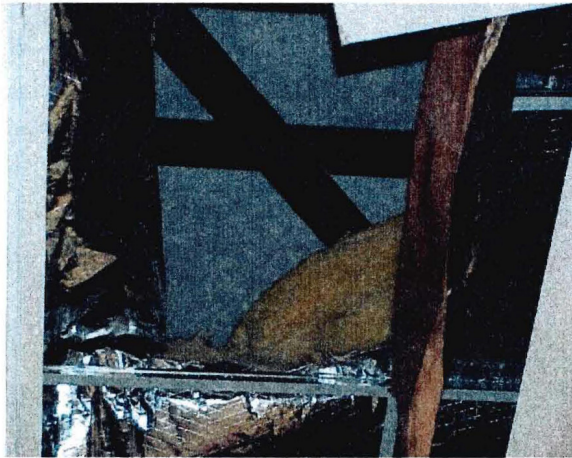
**Figure 12** Missing air barrier & insulation that had been moved to gain access to attic.

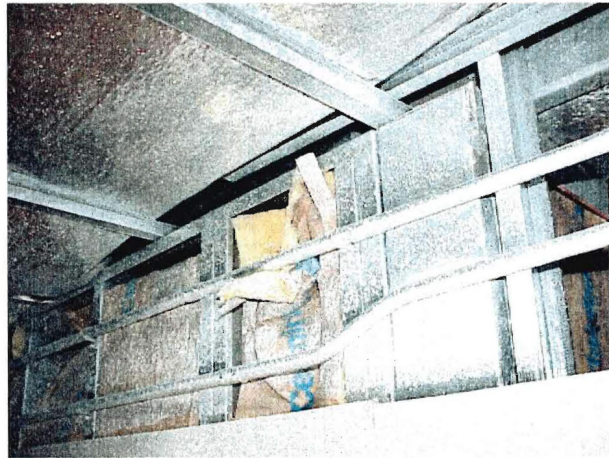
**Figure 13** Incomplete air barrier over t-bar ceiling.

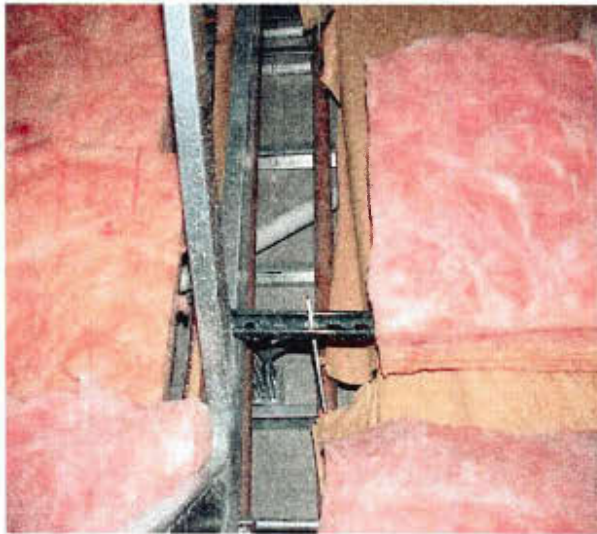
**Figure 14** Typical insulation void approximately 25% to 30%.

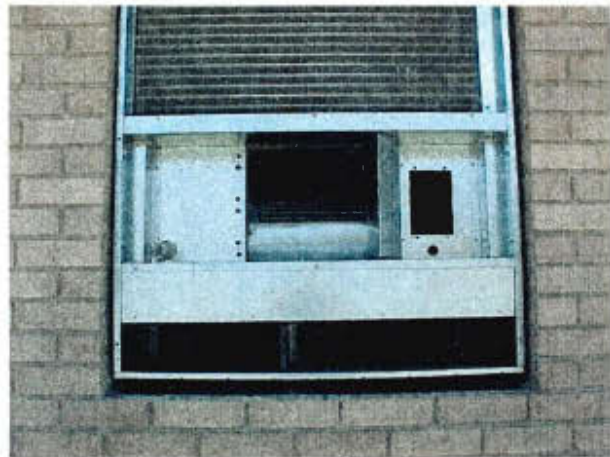
**Figure 15** Exterior view of PTHP unit with grille assembly removed. Approximately 1 inch of clearance exists between the unit and the wall.
