EVALUATE DEPLOYMENT OF PHOTOVOLTAIC SYSTEMS FOR DISASTERS

Final Report

FSEC-CR-1236-01

July 30, 2001

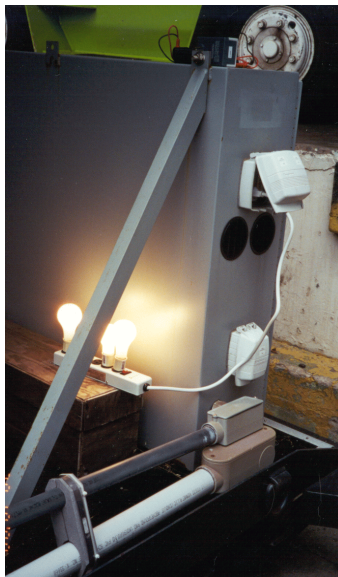
Figure 5 Invertor load test

The output of the inverters was tested using the lamps starting with a 5 watt lamp and increasing in wattage until all the lamps were used. This procedure tested the low wattage turn-on operation of the inverters and ramped the inverter output to nearly half of the inverter's rating. The inverter's operation with an electronic load was tested by use of only fluorescent lamps with an electronic ballast. The drill tested the operation of the inverter with inductive loads. The inverters passed the test and operated as expected except for the one failed inverter in Unit #3.

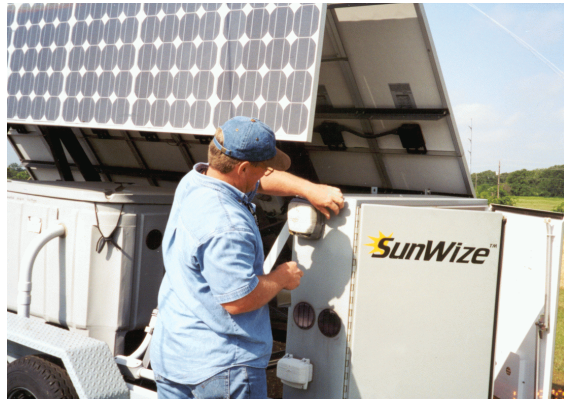
One unit's AC power outlet cover was broken off. A piece of plastic was taped over the cover of the outlet box as shown in Figure 6, since the proper cover could not be obtained locally. A new cover was in the process of being located, but these covers are not typically stocked. If one cannot be found, then the complete outlet box should be replaced.

Figure 6 Repairing power outlet cover in Denton unit

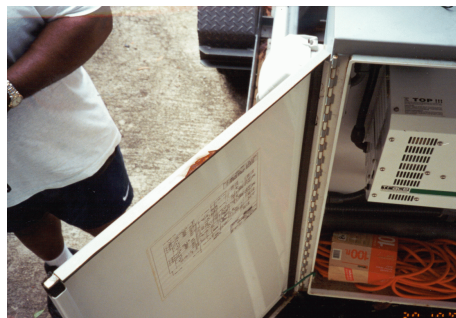
Two of the units had electrical cabinets with small puddles of water inside on the floor of the cabinet. It was difficult to determine the source of the water leak without proper equipment. In Puerto Rico, the electrical cabinet was getting rusty along the edge of the doors, as shown in Figure 7.

Figure 7 Rust on cabinet doors on Puerto Rico unit

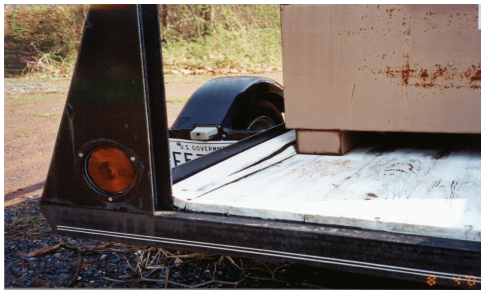
Permission was obtained to display one of the Emmitsburg units at the National Hurricane Conference in Washington, DC during the same week as the site evaluation. One of the smaller units was chosen, since it would be easiest to transport to the conference. After inspecting the units, the PV system on trailer 8 was found to be falling through the floor, and trailer 5 showed similar floor damage. The wood making up the floor of the APC trailers was rotting, as shown in Figure 8 and

Figure 9. The metal braces that support the wooden floors were breaking away from the frame structure of the trailer, as shown in Figure 10. The system enclosure box was sinking into the rotten wood and pushing down the braces that had broken loose to a position below the main trailer frame, as shown in Figure 8. The paint on the floor was peeling off, and the wood did not appear to be hardwood or pressure treated wood. Also, note the rust on the APC trailer system enclosure in Figure 8.

Figure 8 Enclosure sinking into wooden floor

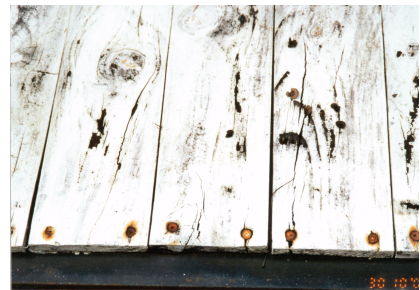
Figure 9 Paint peeling off

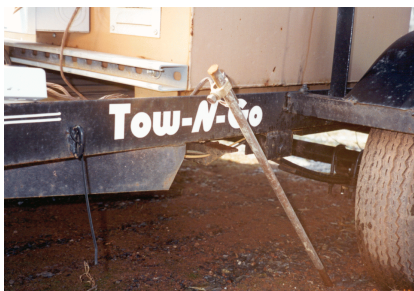
Figure 10 Floor brace breaking away

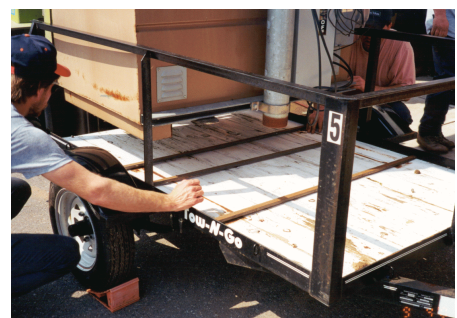
Figure 11 Temporary floor fix

The previous year, the PV system on unit # 5 was removed from the trailer and placed on a platform in front of the Dining Hall. The trailer was then placed in storage. Unit # 8 was being used to power the Burn Building Complex. Trailer # 5, in storage, was in the best condition so the PV system on trailer # 8 was relocated to trailer # 5 for the trip. A temporary fix was made to trailer # 5 by placing metal bars under the enclosure to strengthen the flooring so the enclosure would not fall through as

shown in Figure 11. The new system constructed from PV system # 8 and trailer #5, then traveled 75 miles to the conference where it was displayed for three days and returned to Emmitsburg. It should be noted that, since PV systems on trailers # 5 and # 8 have been exchanged, trailer # 8 no longer has a PV system mounted on it. Since then, FEMA has replaced the wood and repaired the frame on Trailer # 5.
