## **Indoor Air Quality Impacts of Uncontrolled Air Flow and Depressurization in Eight Commercial Buildings in Central Florida**

**James B. Cummings, Charles R. Withers, Philip W. Fairey,**  
**Bruce McKendry, and Neil Moyer**  
Florida Solar Energy Center (FSEC)

FSEC-PF-414-95

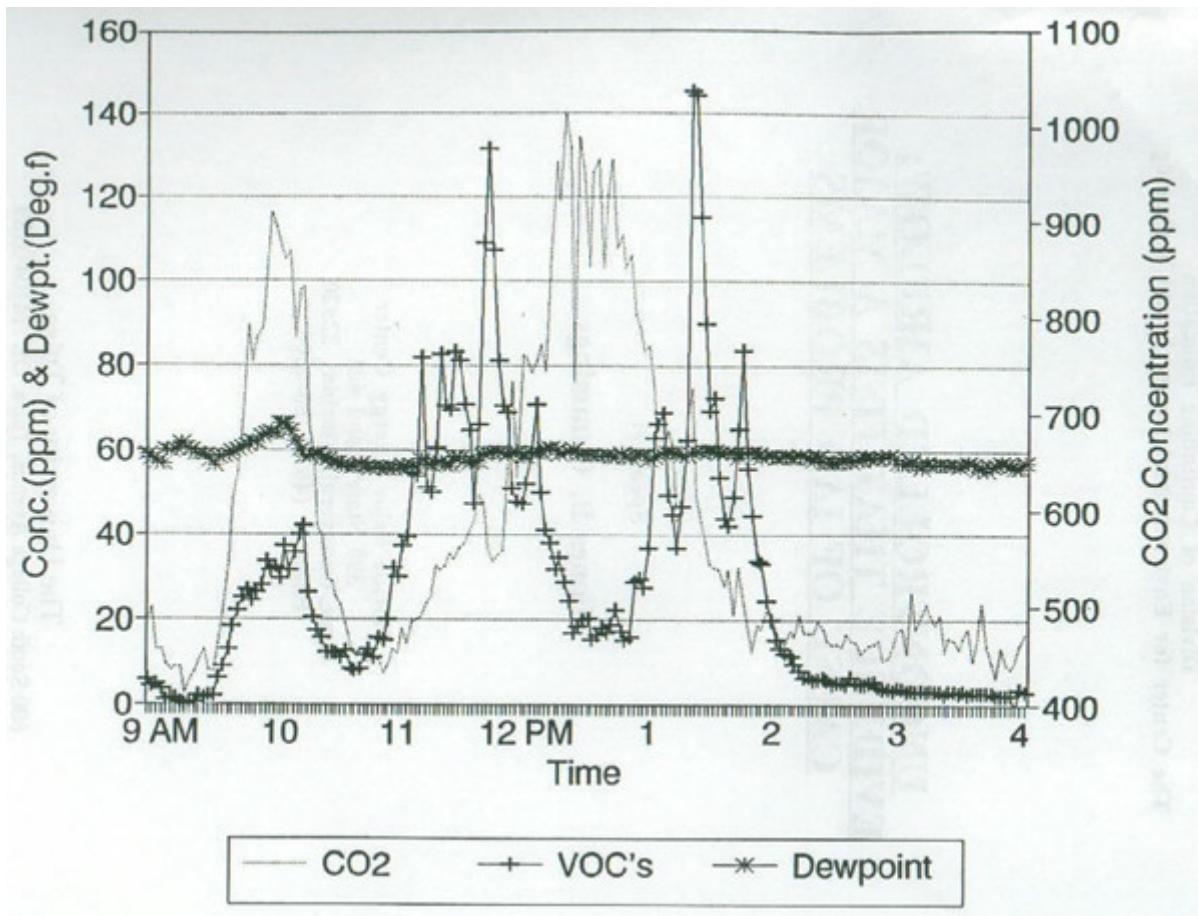
Figure 1. Monitoring of carbon dioxide, volatile organic compounds (VOCs), and dewpoint temperature in a fast-food restaurant. Elevated VOC levels resulted from gases being drawn from sewer pipes.

High organic compound readings, also shown in Figure 1, were a surprise, since no significant source of volatile organic compounds had been identified and the building was well ventilated (5.3 ach). The source, it turned out, was a toilet that was improperly seated. Given the  $-0.10$  inWC ( $-25$  Pa) of depressurization, gases inside the sewer pipes were being drawn into the bathroom and into the store. Perfume dispensers had been placed in the bathrooms to mask (unsuccessfully) the unpleasant odors.
