# FSEC Energy Research Center

## Metal and Flexible Duct Systems Impacts upon Cooling Energy and Performance

FSEC-CR-2105-21

### ***Final Report -***

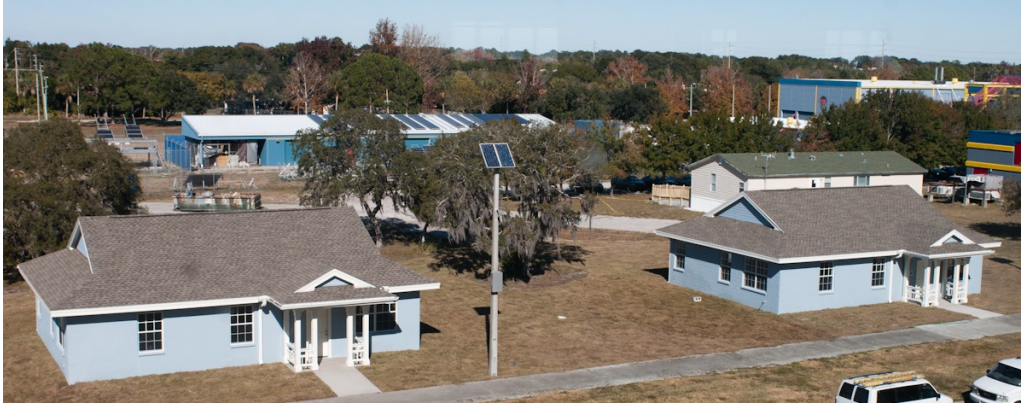
**Figure 1. Flexible residential test structures on FSEC campus. The house on right side is East of the left one.**

Experimental work was conducted in FSEC's Flexible Residential Test Facility (FRTF), which features two full scale, geometrically identical side-by-side residential energy research facilities as shown in Figure 1. General characteristics of the 1,536-ft<sup>2</sup> single-story buildings (volume = 14,285 ft<sup>3</sup>) including details of the general instrumentation package are provided elsewhere (Parker 2014). Internal loads were established using guidance from a Building America report on internal residential loads (Hendron and Engebrecht 2010). Internal cooling loads were maintained consistently by keeping the building unoccupied and providing internal sensible and latent heat through controlled measures. Interior sensible loads were generated using heat lamps on a schedule that represents hourly variability throughout the day for an occupied building. Latent interior generation was produced using industrial-grade ultra-sonic humidifiers also on a daily schedule. The interior loads were monitored to verify they operated according to schedule and that they were the same in each lab.

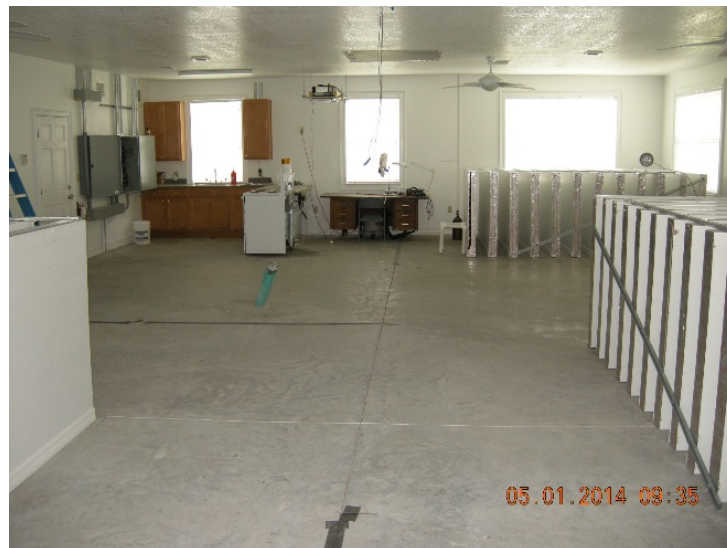
**Figure 3. Interior of West FRTF Lab Building showing interior wall modules (identical to East lab).**

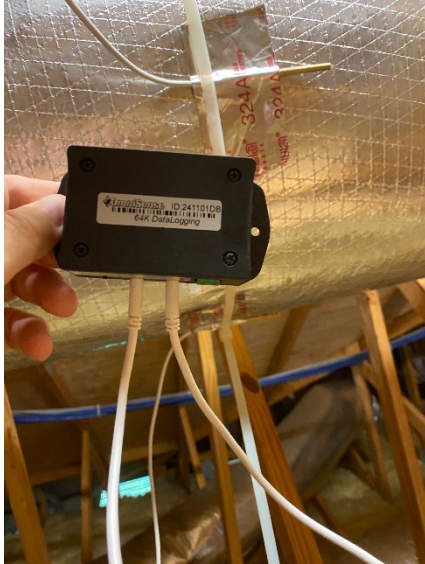
**Figure B2. Temperature and RH sensor logger used on and around ducts in attic.**

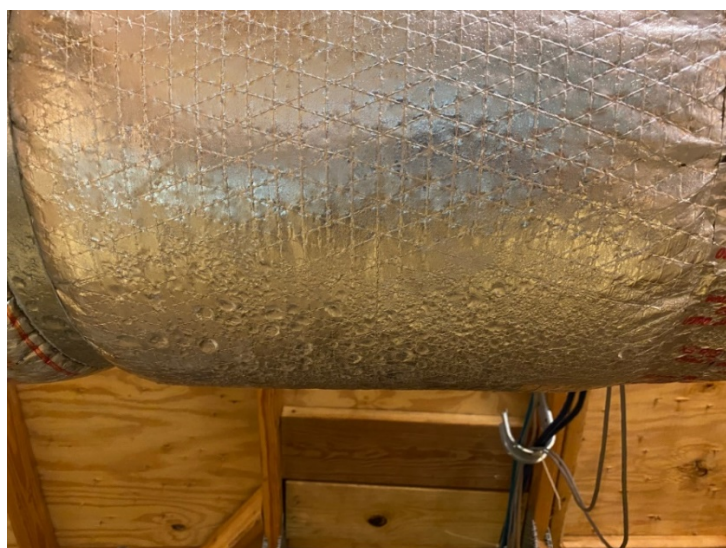
In August 2020, condensation on the exterior insulation jacket was noticed on most of the main trunks and on most branches. It was most noticeable on the bottom where larger drops formed. Figure 1 shows a photo taken August 24, 2020 at a main trunk section about mid-way down the main trunk line.

**Figure 1.** Significant water condensation on exterior insulation jacket wrapped around an airtight metal duct supply system in a vented attic August 24, 2020.

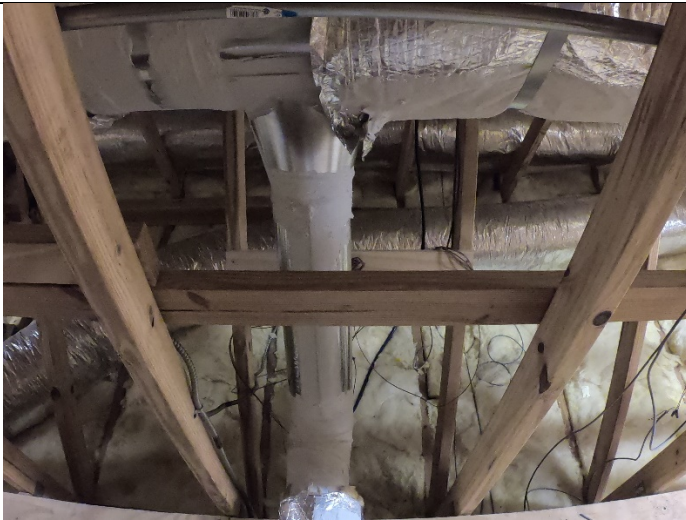
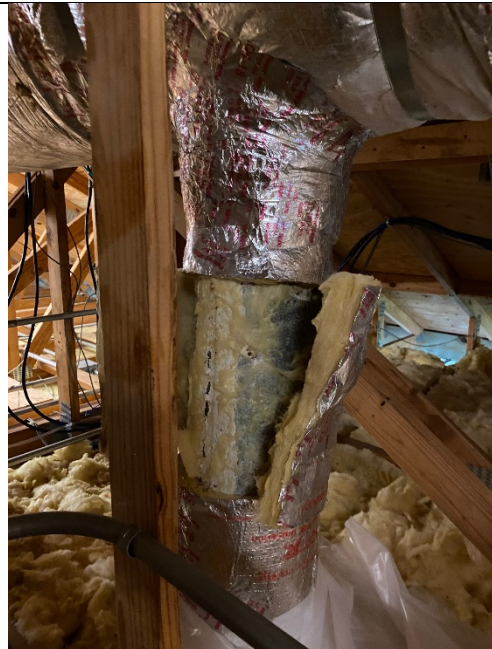
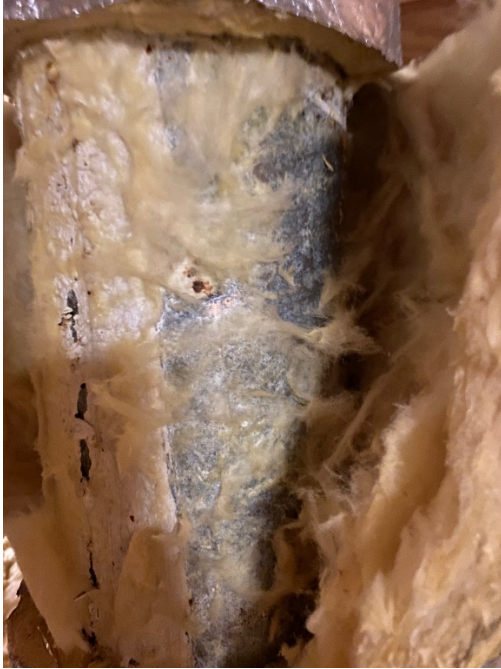
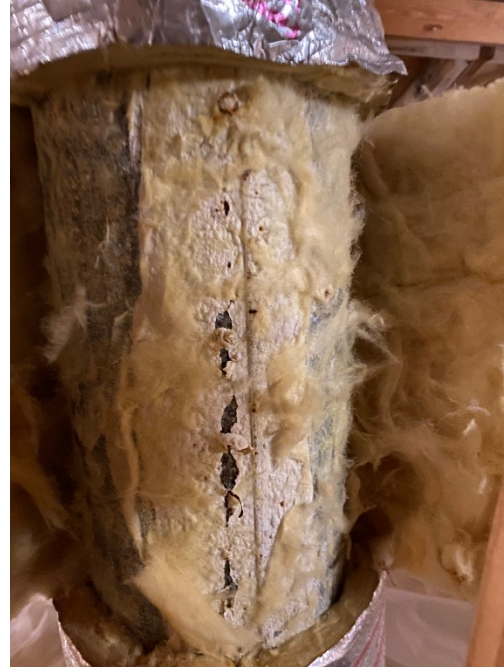
The first sample was marked as “B1” and was taken from around a 7 inch diameter metal duct. The top side of sample was taken from 8 inches below the trunk to branch transition and width of cut was 12 inches. This branch duct is the first supply drop from the system and is 100% vertically oriented. There was a lot of condensation on the outside of jacket, however there was no obvious collection of water trapped inside the insulation jacket. This is likely due to the vertical nature where any water inside jacket had drained down the vertical branch onto the top of the supply boot box and then ran down through ceiling. The circumference of existing jacket as found before cutting out was measured at 28.5 inches. If the insulation has an R-value of R6 at about 1.6 inches thick, then the jacket circumference should have been about 32.2 inches. This indicates significant compression and less than R6 insulation.

**Figure 3.** A shiny new duct branch “B1” is shown here during installation in June 2019.

**Figure 4.** “B1” sample taken November 25, 2020 is looking much duller.

**Figure 5.** B1 metal duct shows signs of some water marking and corrosion. Except for corrosion, the mastic seal was in good condition.

**Figure 6.** B1 metal duct with insulation pulled away showed thickness of about 1"-1 1/4". The rips in mastic seam occurred during sample retrieval.

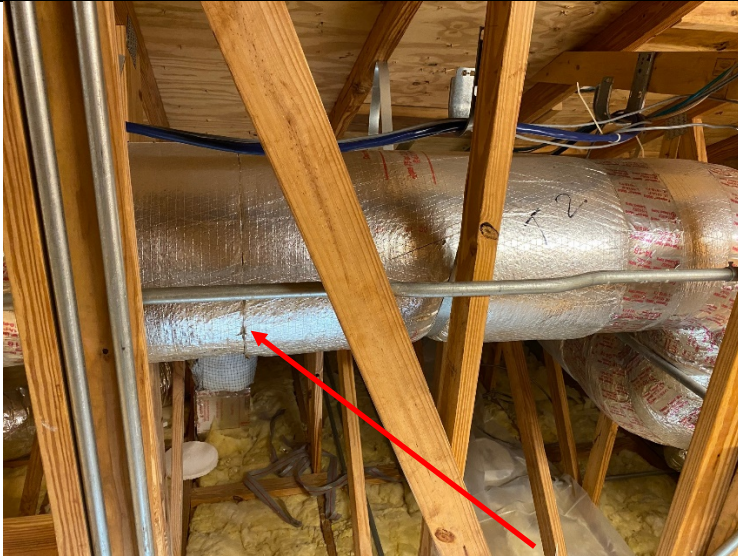
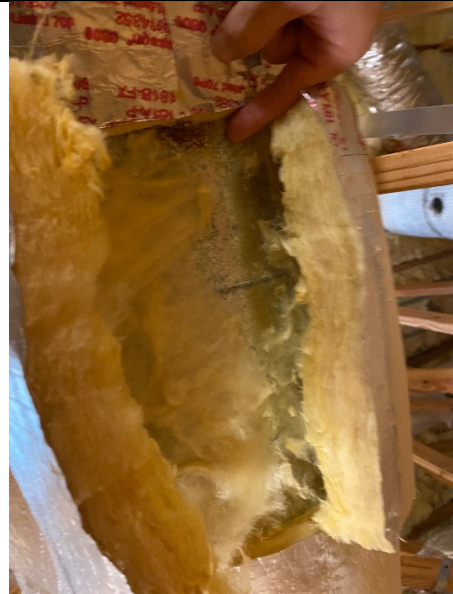
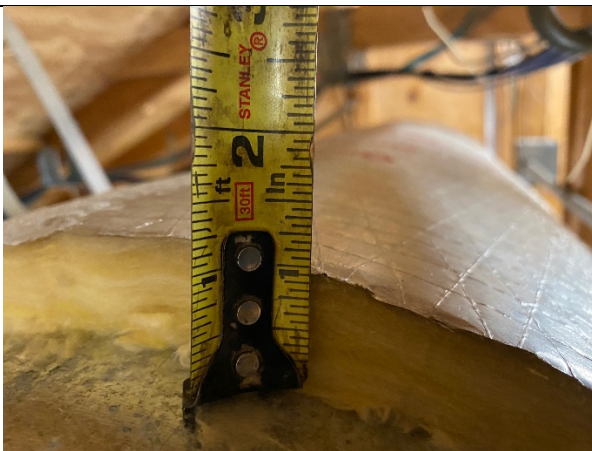
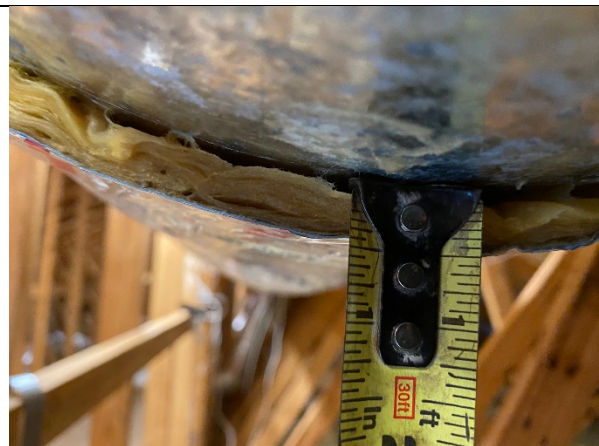
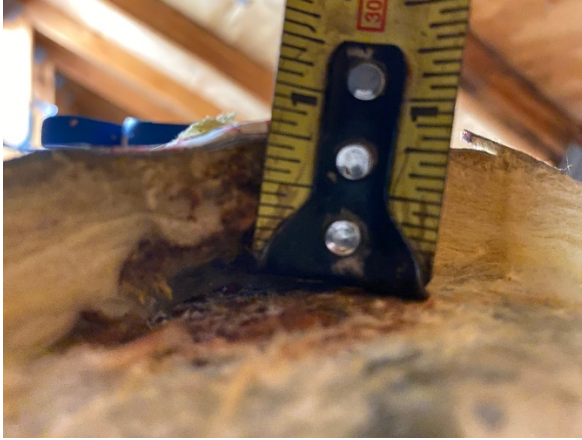
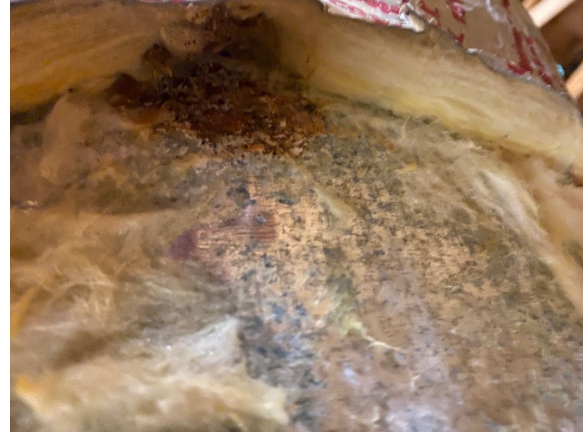
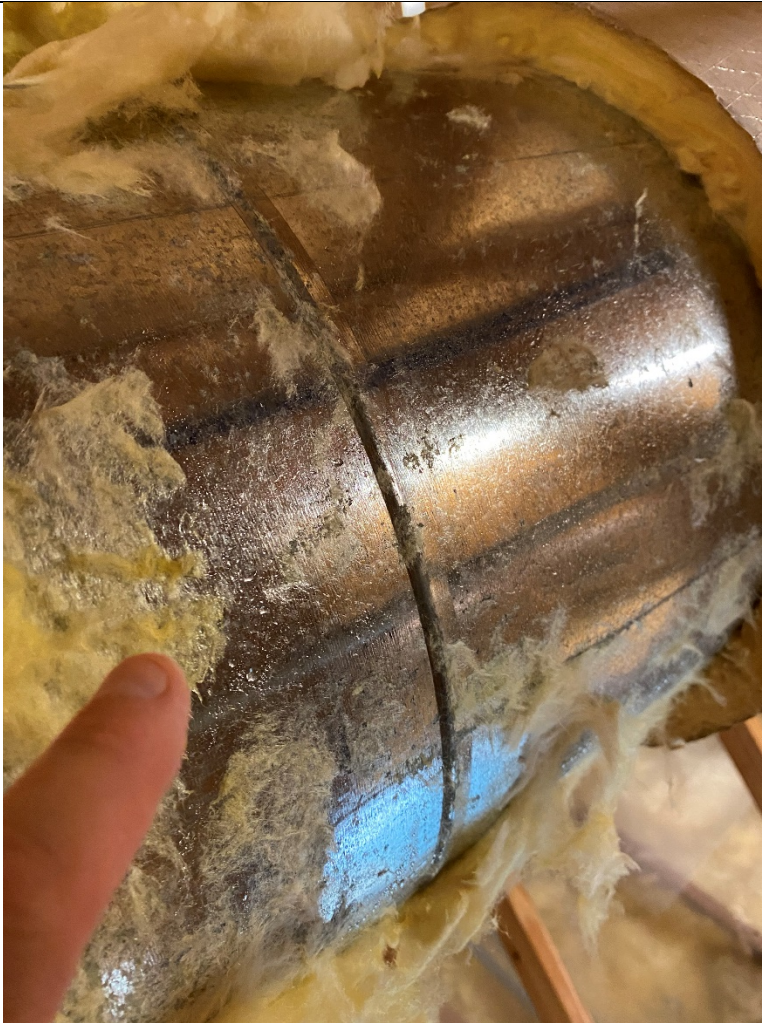
The second sample was marked as "T2" and was around a 14 inch diameter metal duct. The right side of this sample was taken 39 inches downstream of a 90 degree turn from south to east direction. The width of cut was 12 inches. This trunk duct section was horizontally oriented. There was a lot of condensation on the outside of jacket and substantial collection of water inside jacket. The circumference of existing jacket as found before cutting out was measured at 51.0 inches. If R6 insulation is at about 1.6 inches thick, then the jacket circumference should be about 54.2 inches. This indicates significant compression and less than R6 insulation. The thickness of insulation jacket was measured immediately after sample cut-out. It varied from about 1/2 inch at bottom to 1-1/8 inch thick with an average of about 1 inch thick. The much thinner thickness at bottom is likely due to long-term saturation of water trapped inside at bottom. Observations of insulation before insulation was observed to be wet found the bottom to be thicker than 1/2 inch.

**Figure 7.** Main trunk section "T2" sample section with right side (upstream) sample cut visible.

**Figure 8.** Topside of "T2" with corrosion spot found at left side (downstream) of sample.

**Figure 9.** At top of T2 trunk line on right side of sample.

**Figure 10.** At bottom of T2 trunk line where water was found trapped between duct and insulation.

**Figure 11.** Topside insulation (left side of sample) was about  $\frac{3}{4}$ " thick near the corrosion spot.

**Figure 12.** Another close-up view of corrosion spot at T2.

**Figure 13.** Water droplets observed on metal duct T2 immediately after pulling away insulation sample.

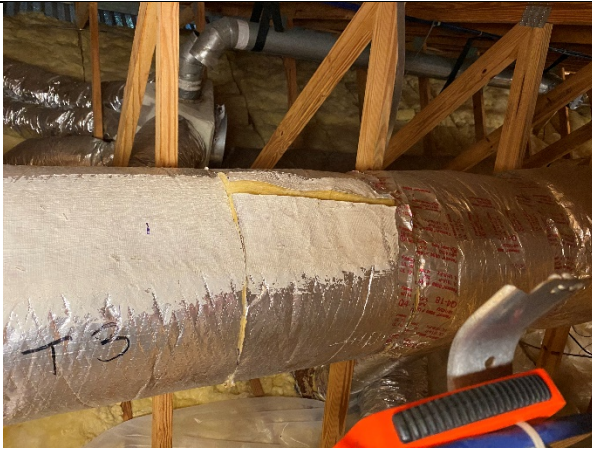
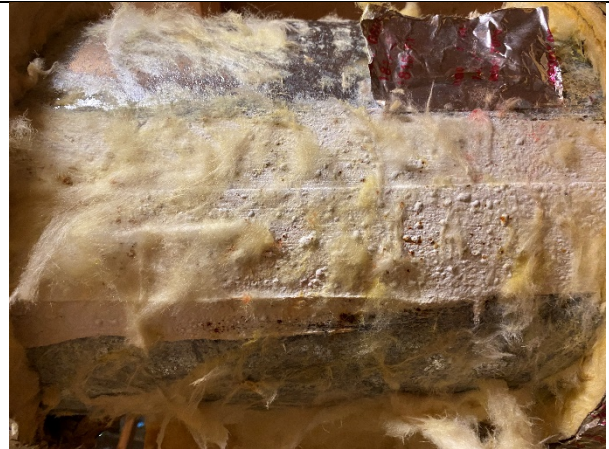
The third sample was marked as “T3” and was around a 12 inch diameter metal duct. The right side of this sample was taken 16 inches downstream of the transition from T2 trunk line to T3 trunk line. The width of cut was 12 inches. This trunk duct section was horizontally oriented. There was a lot of condensation on the outside of jacket and some collection of water inside jacket. The circumference of existing jacket as found before cutting out was measured at 44.75 inches. If R6 insulation is at about 1.6 inches thick, then the jacket circumference should be about 47.9 inches. This indicates significant compression and less than R6 insulation.

**Figure 14.** Sample “T3” before pulling it out.

**Figure 15.** Close inspection at the T3 sample found water droplets near top and on bottom of the metal duct. Corrosion can be seen at the mastic duct seam on metal duct.

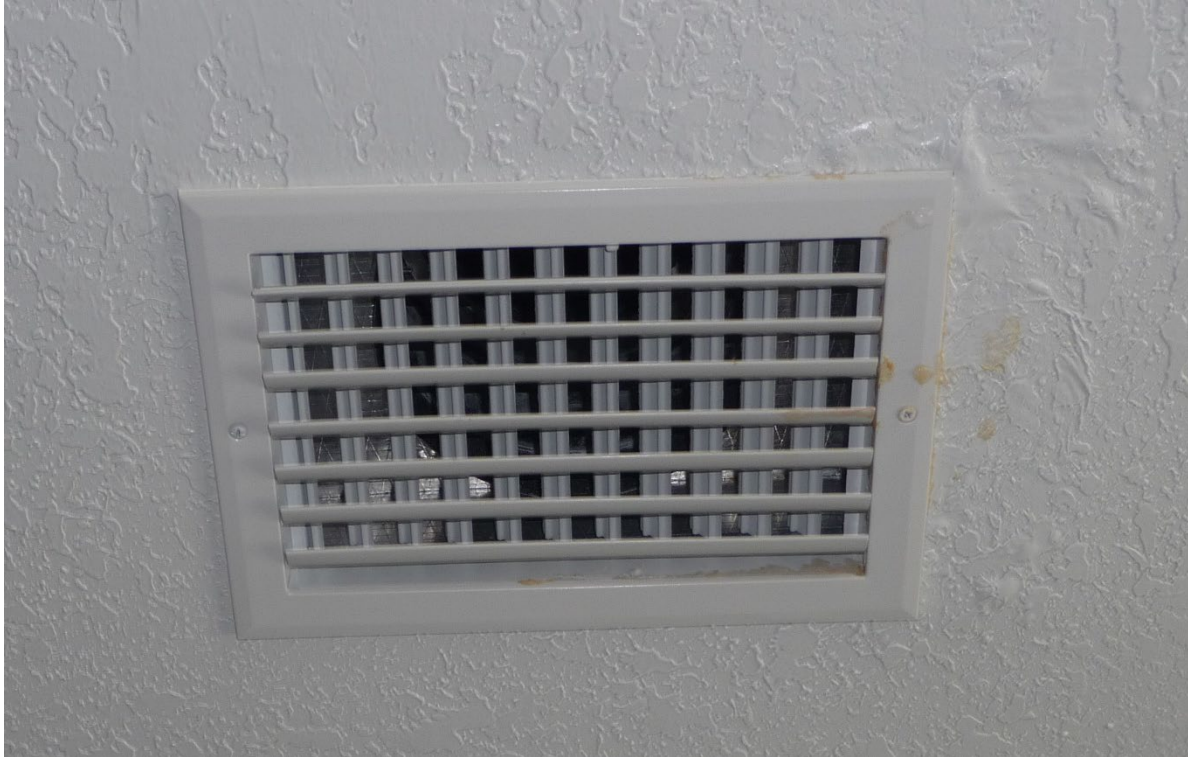
**Figure 16.** supply grille on duct branch B1 has visible water on grille and staining and paint damage on right side. The integrity of the drywall was still good. Photo taken September 18, 2020.

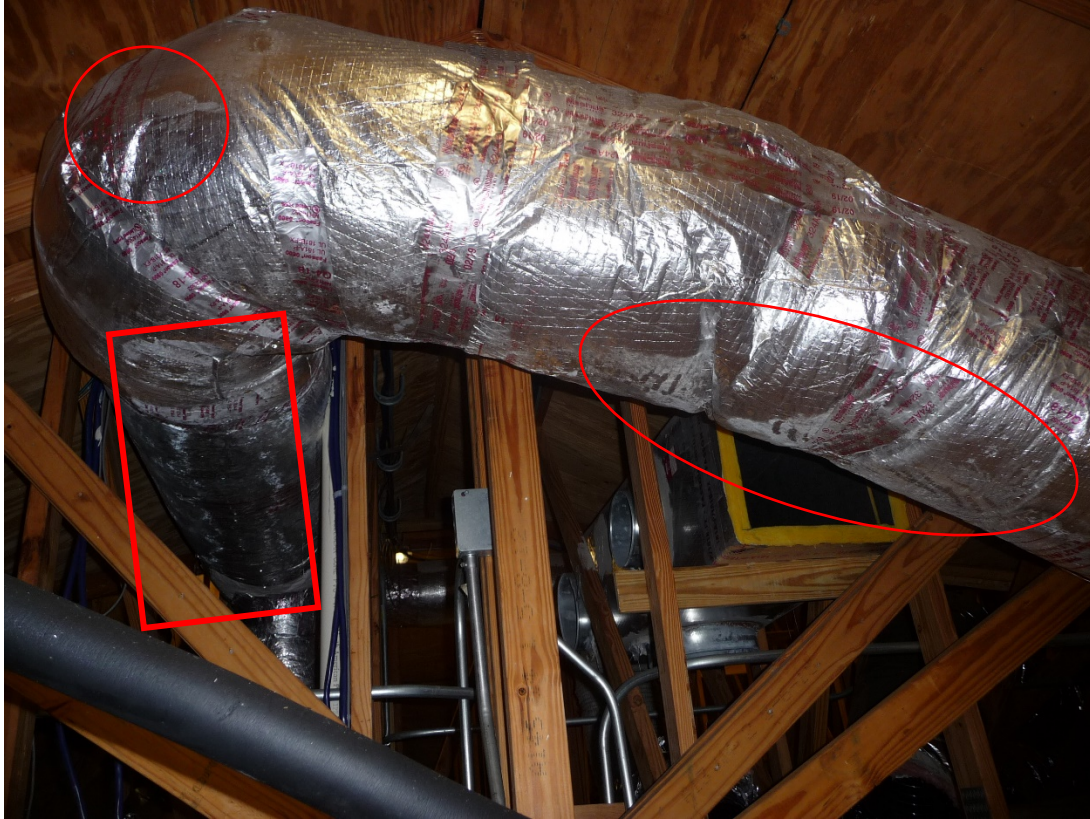
**Figure 17.** Main trunk section T1 shows light condensation on bottom and some sides (red circles). Heavier condensation and water marking is on the bottom of T1 after bend on left side of photo circles by red rectangle. Photo taken September 18, 2020.

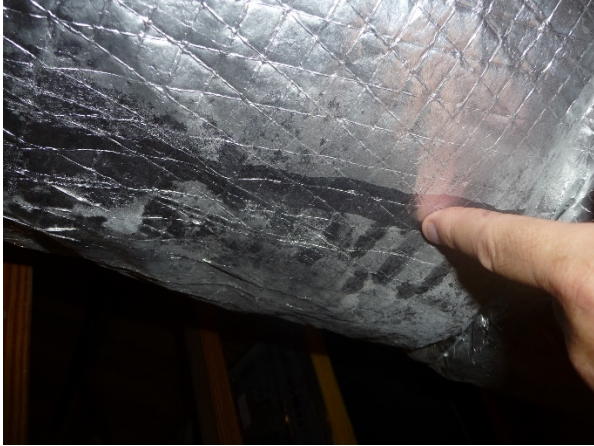
**Figure 18.** Close view of finger swipe on jacket surface shows light condensation on section within the largest circle shown in Figure 17 (9/18/20).

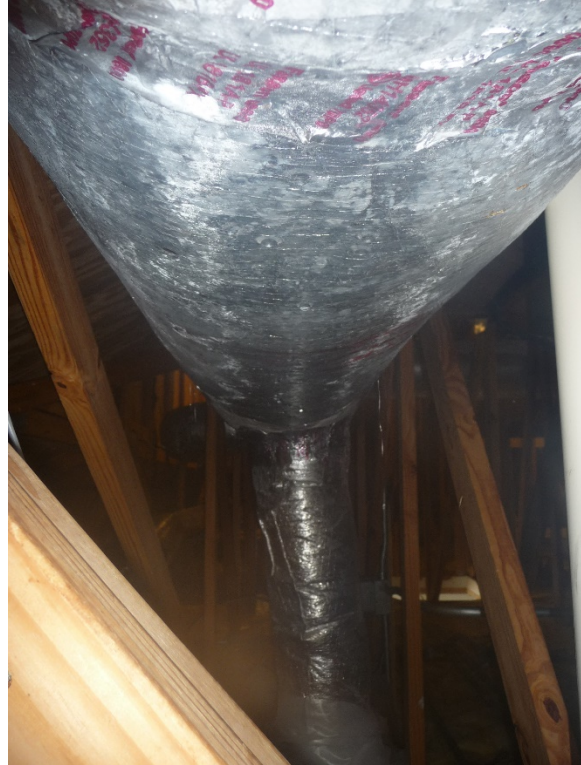
**Figure 19.** Photo of wet bottom on section T1 shown within the rectangle in Figure 17. Large water droplets and light grey water marking can be seen. The duct branch drop B1 is the vertical duct in the background (9/18/20).

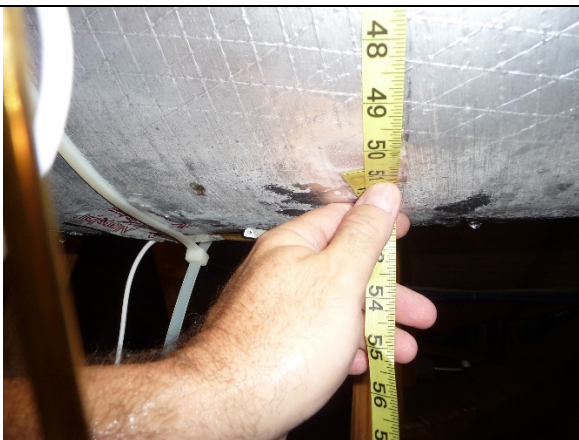
**Figure 20.** Example photo of jacket circumference measurement made on main trunk T2. Light condensation was on sides and larger water droplets on bottom of jacket (9/18/20).

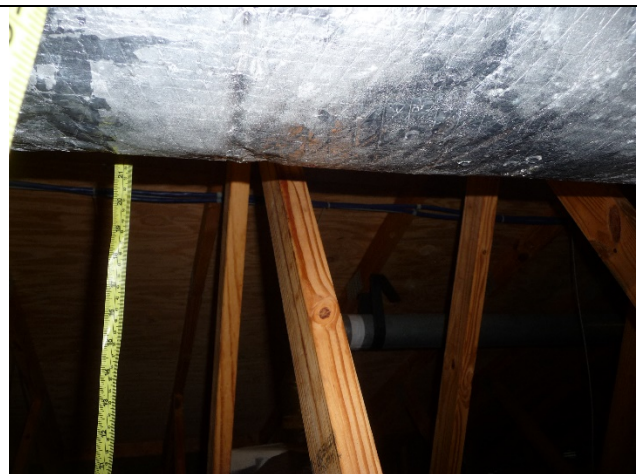
**Figure 21.** Condensation and water drops on bottom of main trunk T3 (9/18/20).

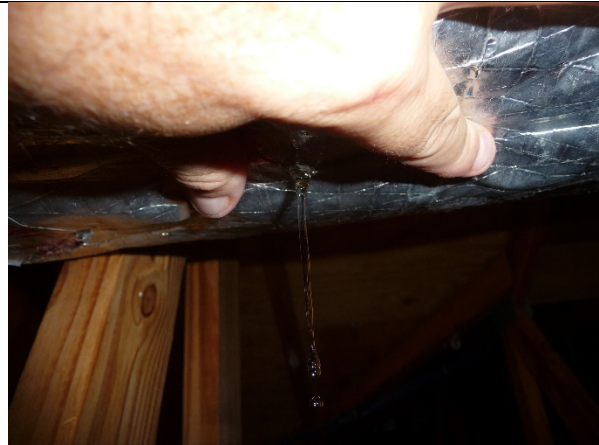
**Figure 23.** A steady stream of water can be seen coming out of the inspection hole in jacket while applying pressure on jacket. Water was trapped inside jacket throughout the main trunks.
