## **Evaluating the Impacts of Uncontrolled Air Flow and HVAC performance Problems on Florida's Commercial and Institutional Buildings**

### **Final Report**

**FSEC-CR-1210-00**

**October 31, 2000**

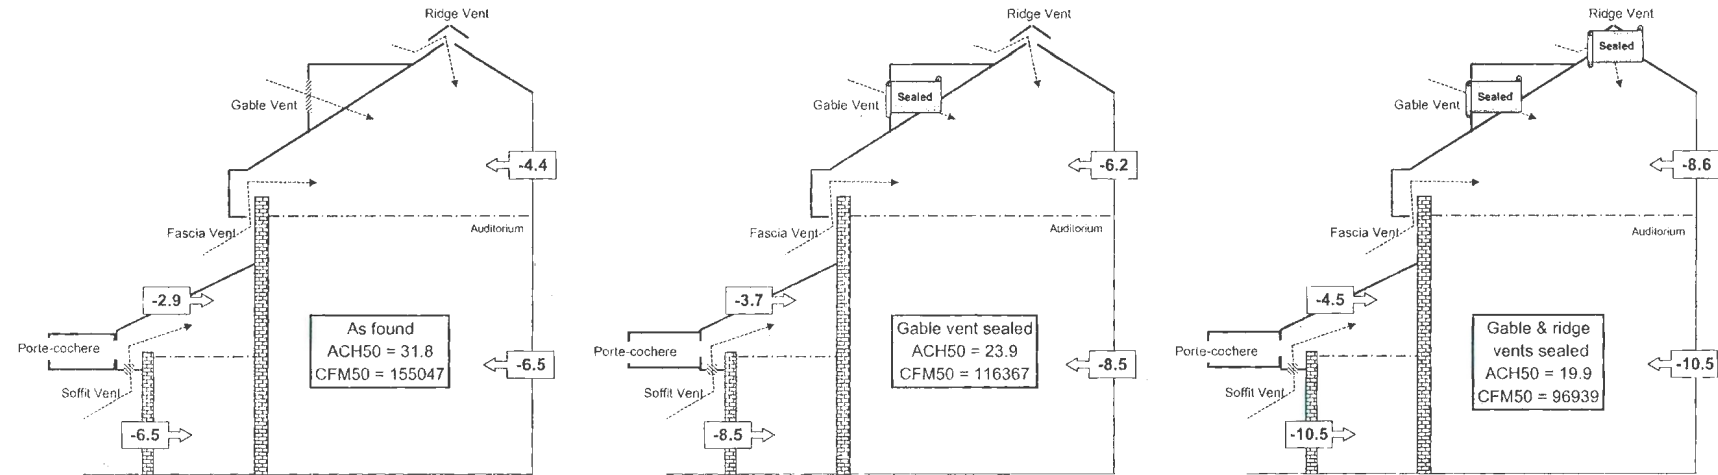
# Building and Ceiling Space Pressures With Respect to Outdoors With Five Blower Doors (~28,300 cfm) at a Clubhouse/Community Center

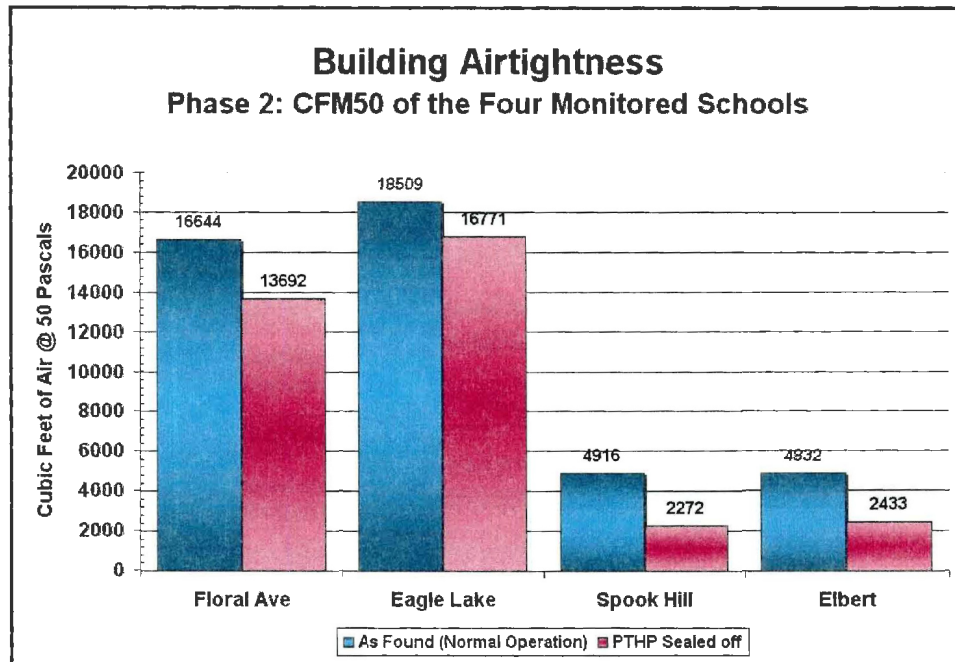
Figure 10. Building airtightness results. Sealing the PTHP resulted an average reduction of 2433 CFM50.

The first set of tests included leakage through the outdoor air intake and exhaust openings in the PTHP units as well as the gap between the equipment and the wall assembly. Testing was repeated with the PTHP units isolated from the building by temporarily sealing all of the exterior grills. This eliminates both the outdoor air intake and exhaust openings in the PTHP units as well as the gap between the equipment and the wall assembly. The airflow was reduced to 15,232 (CFM50=15232) for the metal framed buildings and to 2353 (CFM50=2353) for the AAC buildings. From this we conclude that leakage around the PTHP units averaged 2433 CFM50 for these four outdoor air intake and exhaust openings in the PTHP units as well as the gap between the equipment and the wall assembly buildings, or about 14% of the leakage of the metal framed buildings and 50% of the leakage in the concrete panel buildings. CFM50 can be divided by 13 to yield equivalent hole size in square inches. Thus, the equivalent hole size of this leakage around and through the PTHP units is 316 square inches per building or 79 square inches per PTHP unit.

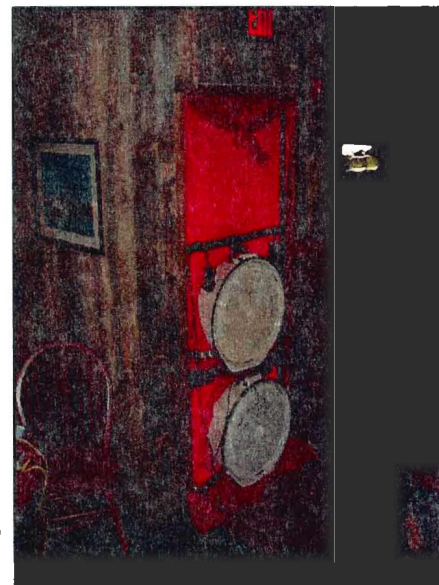
Figure 2. Blower door

A blower door test was performed to characterize the airtightness of the building (Figure 13). In preparation, the kitchen and bathroom exhaust fans were turned off and masked off. The kitchen make-up air was turned off and masked off. The dishwasher exhaust fan was not disabled or masked off, since in our opinion this fan would often be off and therefore would represent a "hole" in the building most of the time (this assumption may be in error). Using two blower doors, a multi-point blower door test was performed. The building was depressurized to a number of pressures ranging from -11.0 pascals to -37 pascals. Test results found a building airtightness of 13,407 CFM50 ( $C=1302.66$ ,  $n = 0.59$ ). CFM50 is the air flow rate through all the cracks, penetrations, and holes in the building envelope when the building is depressurized to -50 pascals. Though we did not achieve -50 pascals, a computer program projects air flow at -50 pascals with considerable accuracy based on the multiple pressures points, so we have great confidence in the projected value.

Given the floor area of 8204 square feet and estimated volume of 82,040 cubic feet, the building airtightness can also be expressed as 9.7 ACH50 (this means that the building air volume is exchanged 9.7 times every hour when the building is depressurized to -50 pascals). ACH50 is the best measure of tightness for comparison to other buildings. The average new small commercial building has an airtightness of about 14 ACH50, so this restaurant is tighter than average. A blower door test summary report is attached to the end of this report. However, this building is still more leaky than our recommendation of 4 to 8 ACH50.

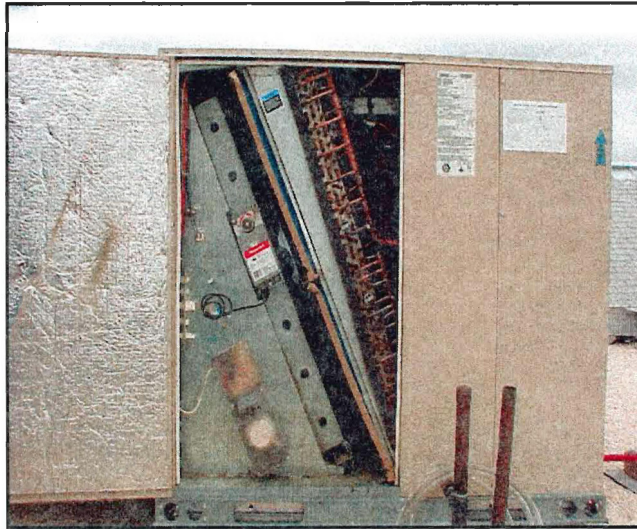
Inspection of the roof top air conditioning units (RTUs) found four 12.5 ton units and one 10 ton unit. Each is a two-stage Lennox unit with face split cooling coil, with the first stage coil being the (physically) lower of the two (Figure 14). The face split arrangement is an excellent choice for this climate, especially since the air handlers are operated in the fan “on” position. With the face split arrangement, half of the total coil surface is fully cold while the other half remains warm (this is with only first stage active). The portion of the air that passes through the cold side is well dehumidified. By contrast, if the arrangement had been split row (alternating rows are cold and warm), then the entire coil would be cool instead of cold, and therefore little dehumidification would occur.

Figure 14. The cooling coil is actually two separate coils, each served by a separate compressor.

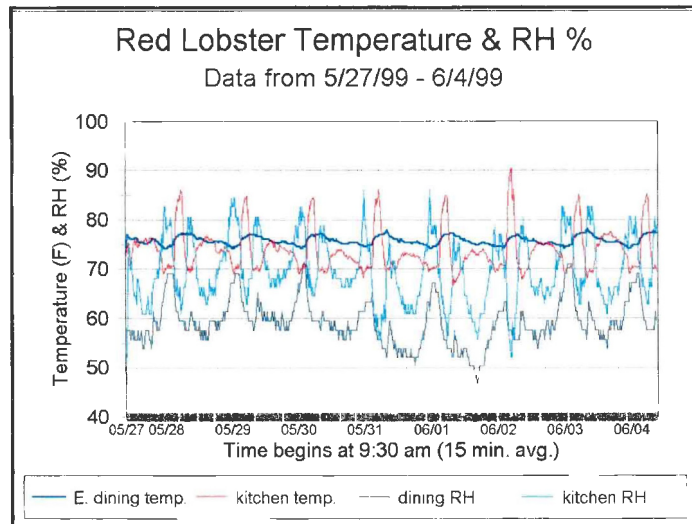
**Temperature** Dining room temperatures remained in a fairly tight range of 74 to 76 degrees during business hours on days with peak outdoor temperatures that averaged about 91 degrees (Figure 18). The hottest days had outdoor temperatures approaching 95 degrees. The fact that indoor temperatures did not experience excursions beyond the 74 to 76 degree range indicates that the AC systems have sufficient capacity to meet load.

Figure 18. Temperature and RH in the kitchen and dining area

Kitchen RH levels were higher than in the dining room. During the majority of business hours, RH was in the range of 65% to 70% (Figure 18). As indicated earlier, these levels are higher than ideal. However, given the considerable rates of humidity generation and high ventilation rates in the kitchen, elevated humidity is not unexpected.

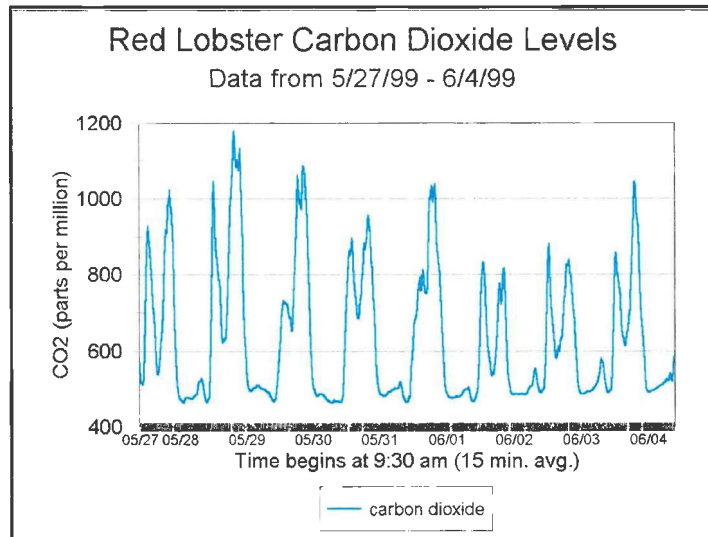
million (ppm) – or about 650 ppm greater than outdoor carbon dioxide levels of 350 to 400 ppm – indicates approximately 15 cfm/person ventilation (assuming a several hour period to reach equilibrium). Measured peak carbon dioxide levels in the dining room were found to be about 1000 ppm (Figure 19). The highest peak was on Saturday May 29 during the evening with a peak of about 1100 ppm. On other days of the week, peak carbon dioxide levels were primarily in the range of 800 to 900 ppm. Therefore, we can conclude that ventilation rates are reasonably on target.

Figure 19. Indoor dining area CO<sub>2</sub> levels

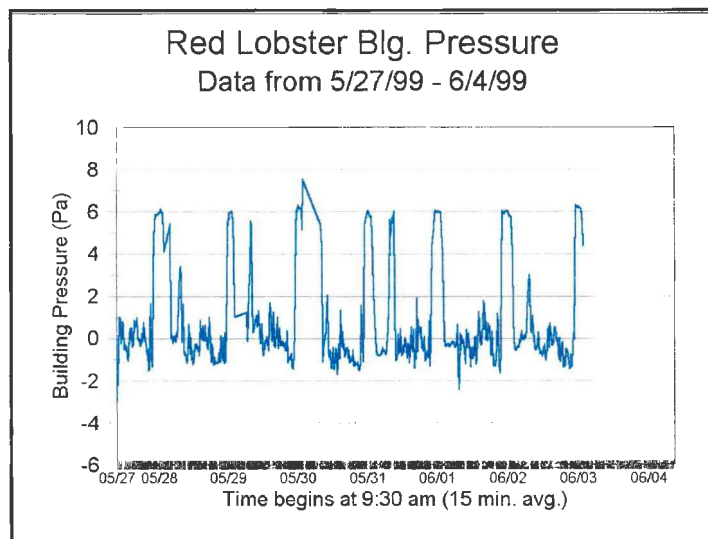
Pressure differential Monitoring found that the building operates at slight negative pressure more than half of business hours. However, the depressurization is generally about -1 pascals with respect to (wrt) outdoors, and during portions of business hours building pressure is in the range of 0 to +1 pascals wrt outdoors (Figure 20). Each day beginning about 11 PM, building pressure goes to about +6 pascals for about 3 hours. Note that during this three hour period the dining room temperature remains steady at about 75 degrees but RH increases steadily from about 60% to about 68% (Figure 21). We do not know the reason for this increase but it may occur because the exhaust fans (with make-up air) are turned off while outdoor air continues to operate (see summary third bullet). It may also occur as a result of the economizers opening up. (We do not know why the economizers would activate at this time, but if they did so the added ventilation air would tend to elevate humidity.) The increase of approximately 7 pascals (from -1 pascals to +6 pascals) indicates a net increase of air flow into the building of

Figure 20. Indoor pressure wrt outside over several days

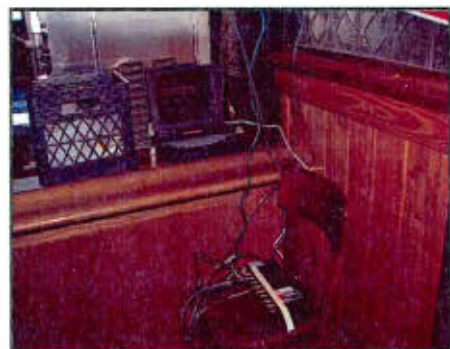
Figure 23. Eight-channel pressure monitor with computer display helps in diagnostic testing.

The normal operating pressure (NOP) of the building was determined with all five roof top units (RTUs) operating, both make-up air (MA) units operating, and all exhaust air (EA) systems except the dishwasher operating. NOP was found to be -2.7 pascals (wind < 3 mph). (Figure 23) This means that the building normally operates at -2.7 pascals with respect to (wrt) outdoors, and it is therefore sucking air into the building. When the dishwasher EA is also turned on, building pressure goes to -5.0 pascals.

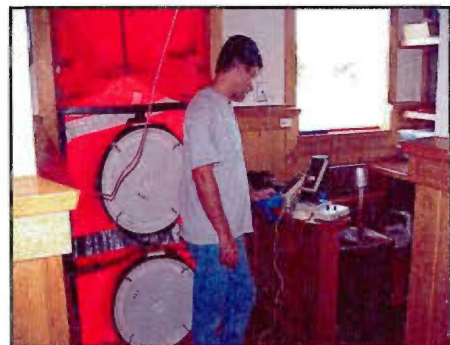
Figure 24. Blower door set-up installed in pick-up doorway.

A blower door test was done to determine building airtightness (Figure 24). In preparation, all EA and MA units were turned off and masked off. The RTUs remained on but the outdoor air (OA) intakes were masked off. CFM50 was found to be 12,021. [The airtightness curve for the building is defined by an equation  $Q = C \times \Delta P^n$  where  $C = 989.4$  and exponent  $n = 0.64$  (see Figure 4). Using this curve, we can project air flow into the building for any given building air

pressure.] The air flow rate into the building caused by space depressurization of 2.7 pascals is calculated as 1868 cfm [ $Q = 989.4 (2.7)^{0.64} = 1868$  cfm]. At -5.0 pascals (the building pressure with the dishwasher EA also operating), the flow into the building is calculated to be 2772 cfm. This indicates a dishwasher EA flow rate of roughly 904 cfm (2772 cfm - 1868 cfm = 904 cfm). (Note that measurements at the roof discharge found that the dishwasher EA was moving 956 cfm.)

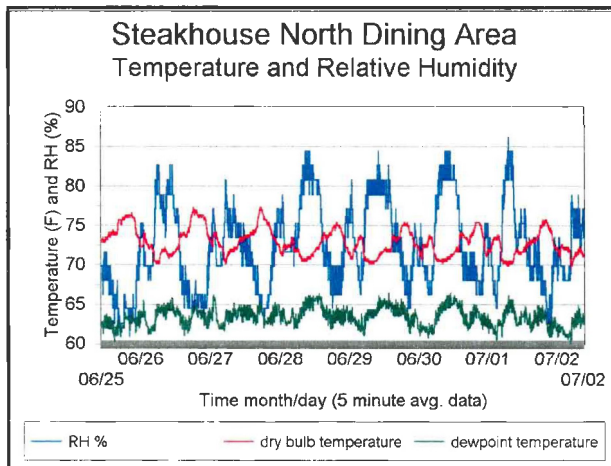
Figure 26

Indoor conditions were running at about 71 degrees F and 70% relative humidity (RH) during the period from 10 AM to 12AM on the day of our testing. Additional data is available for a seven-day monitoring period (Figure 26). Dining room temperatures follow a daily pattern; they rise in the afternoon to about 76 degrees F and fall to about 70 degrees F overnight. RH falls primarily within the range of 65% to 85% which is well above the recommended range of 50% to 58%. The range of 40% to 50% is also considered acceptable, however lower RH levels require greater energy expenditures. On the other hand, RH greater than 70% is considered unacceptable because it is uncomfortable and more importantly can lead to mold and mildew growth.

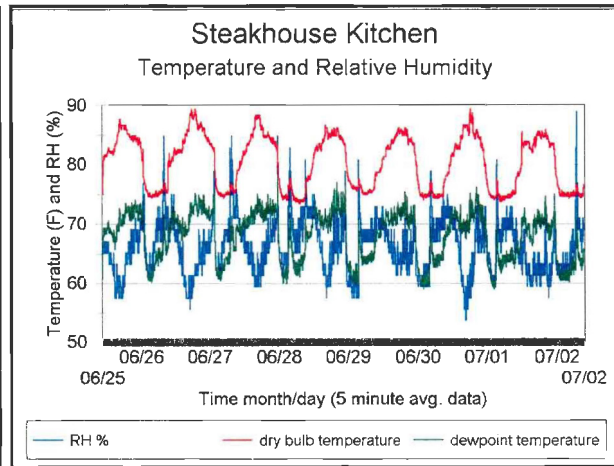
Figure 27

Conditions in the kitchen are less favorable compared to the dining area (Figure 27). Overnight, room temperature falls to about 74 degrees F. However, as soon as the EA is turned on in the morning, the kitchen temperature goes to about 80 degrees F and then rises into the afternoon, often reaching 85 degrees F or higher. RH in the kitchen averages about 65%. Kitchen dewpoint temperature is mostly in the range of 70 to 75 degrees F when the EA is operating, and drops to about 63 degrees during the nighttime hours when the EA is off.

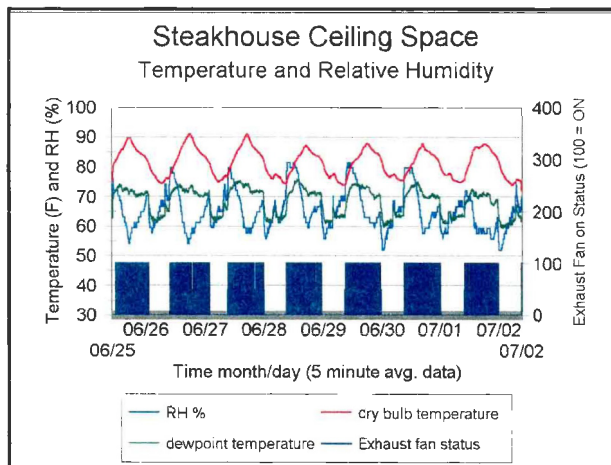
Figure 28

Conditions in the ceiling space are considerably warmer and more humid than in the dining area. During the hours of EA operation and the building is depressurized, the ceiling space dewpoint temperature is about 71 degrees F (Figure 28). On the day of testing, we found ceiling space conditions of 81 degrees F, 67% RH, and 71 degrees F dewpoint temperature immediately on top of the ceiling tiles at 3 PM. During our week of monitoring we found that ceiling space temperatures were peaking at about 85 to 90 degrees F midpoint between the ceiling and roof deck.

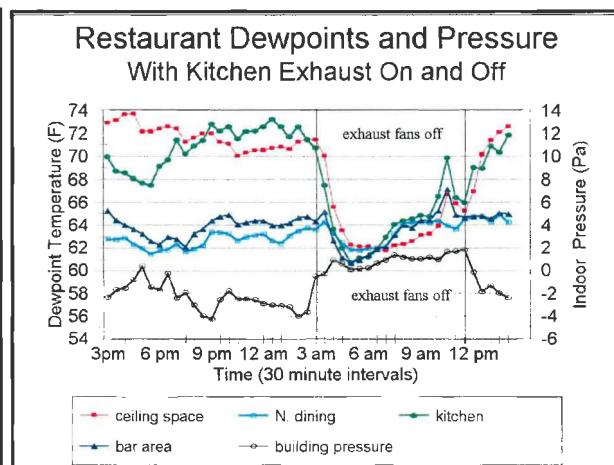
Figure 29

Note however, that during the night when the EA was off and the building was at +1 pascal pressure (positive pressure because of OA), the dewpoint temperature in the ceiling space declined abruptly to about 62 degrees F (see Figure 29).

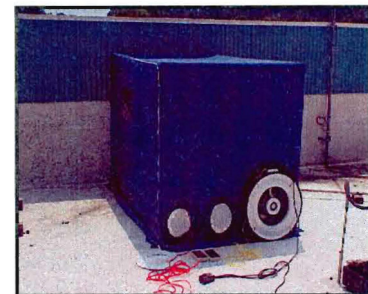
Figure 31. Capture tent measuring air flow rate of MA unit.

While total exhaust air flow is close to design and total OA is only slightly less than design, MA is 41% below design (4980 cfm measured versus 8420 cfm design). We recommend reducing EA flows as much as possible while still maintaining effluent capture and increasing MA to the level required to create slight positive pressure in the building. Testing would be required to determine the optimal level of EA and MA to achieve both effective capture of cooking effluents and minimization of energy consumption. We recommend that MA be rerouted so that it is delivered outside of the hood in order to optimize the ability of the MA to capture cooking effluents on its journey into the exhaust hood. Use of theatrical smoke generation is recommended to optimize the MA discharge pattern.

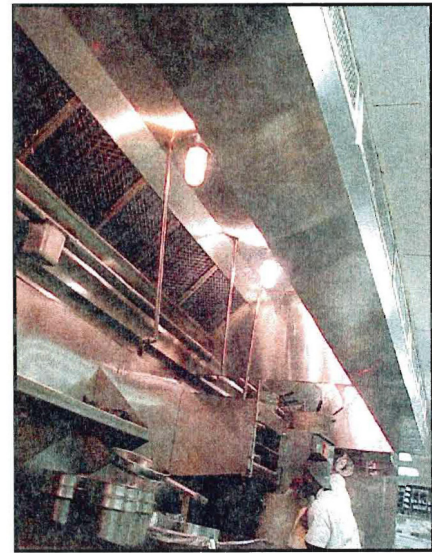
MA should be increased to bring the building to slight positive pressure. Increasing MA flow raises the issue of where and how to discharge this air. Currently, two of the hoods discharge air both internally (inside the hood) and to the room. We feel that internally discharged air does not provide much benefit, and that it would be better to reduce the EA flow rates, increase the MA flow rates somewhat, and discharge all of the MA in front of the hoods (Figure 32). (Testing would need to be done to verify that the exhaust hoods still capture the cooking effluents with the lower flow rate.)

Figure 32. Kitchen hood with both external and internal MA discharge.

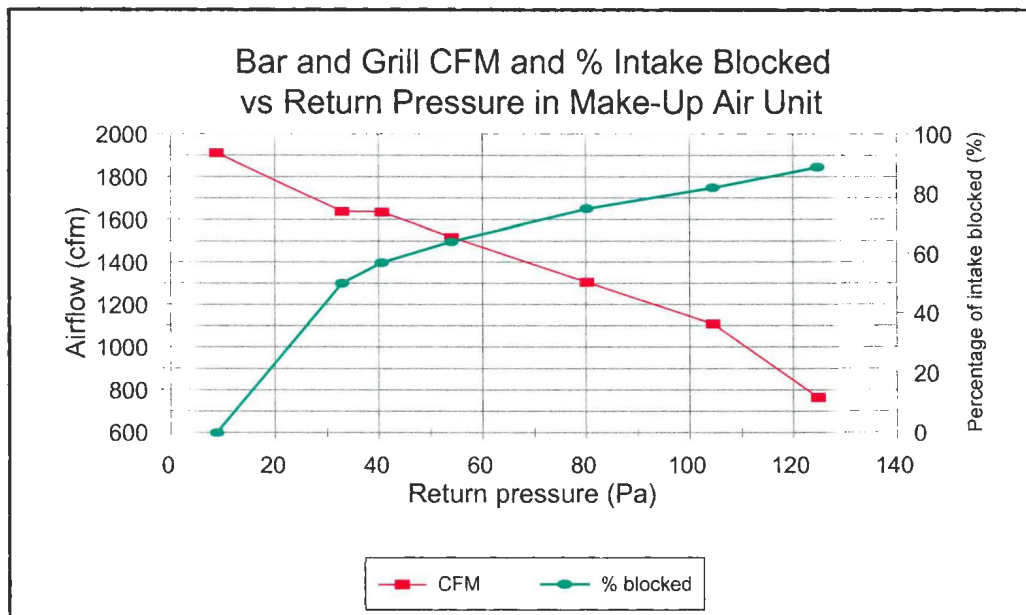
The exhaust flow rate was measured and found to be 1135 cfm, an increase of 19% from 954 cfm measured prior to the retrofit. The target MA amount of 80% of the exhaust air could not be reached until 85% of the total intake grill area was sealed. Figure 1 shows test results from the MA unit using the original motor. (The airflow was measured using a flow-hood over the intake grills and does not include any return leakage in the unit.)

**Figure 1** Airflow vs pressure on return side of MA unit

Sealing off 85% of the total intake grill area to get the correct amount of airflow indicated that the current ½ horsepower motor was oversized and that using a smaller motor could still deliver the airflow needed and use less energy. A replacement motor was specified and the original motor was replaced by the contractor. Follow-up measurements on February 26 found that the airflow had not declined because the new motor had lesser horsepower (⅓ horsepower) but the same rotational speed (1725 rpm). Finally, after installing a ⅓ horsepower, 1140 rpm motor, we found that we could achieve the target airflow of about 933 cfm through the intakes with 73% of intake grills sealed off.

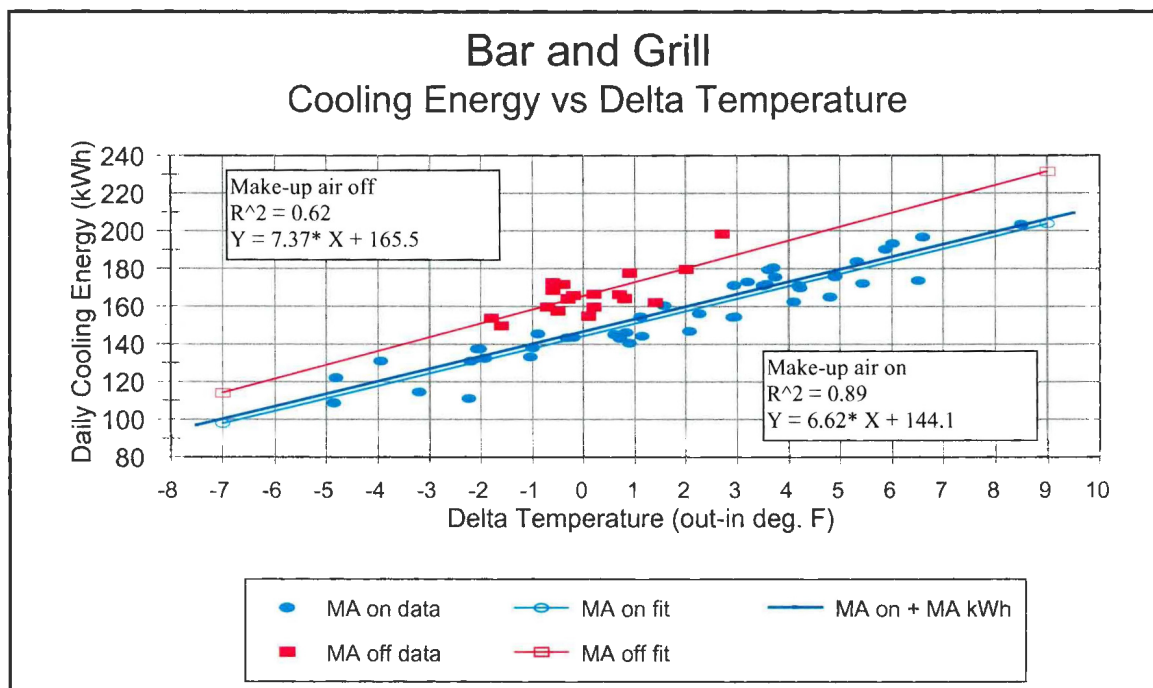
Figure 2 shows the building total cooling energy used versus the daily average temperature difference between indoors and outside. Regression analysis was used to create a linear equation that best represents the data and is shown as a solid line. The red line represents cooling energy used without the MA unit operating. The light blue line represents cooling energy used with the MA unit operating. A third solid line (dark blue) is shown for the MA on data that represents the cooling energy used plus the added energy to operate the make-up air fan. Based on monitoring data, the exhaust and MA operate an average of 12.5 hours per day. Using the measured power of the MA motor, 204.7 watts, over 12.5 hours results in 2.6 kWh/day of MA fan energy use.

**Figure 2** Cooling energy used before and after make-up air retrofit

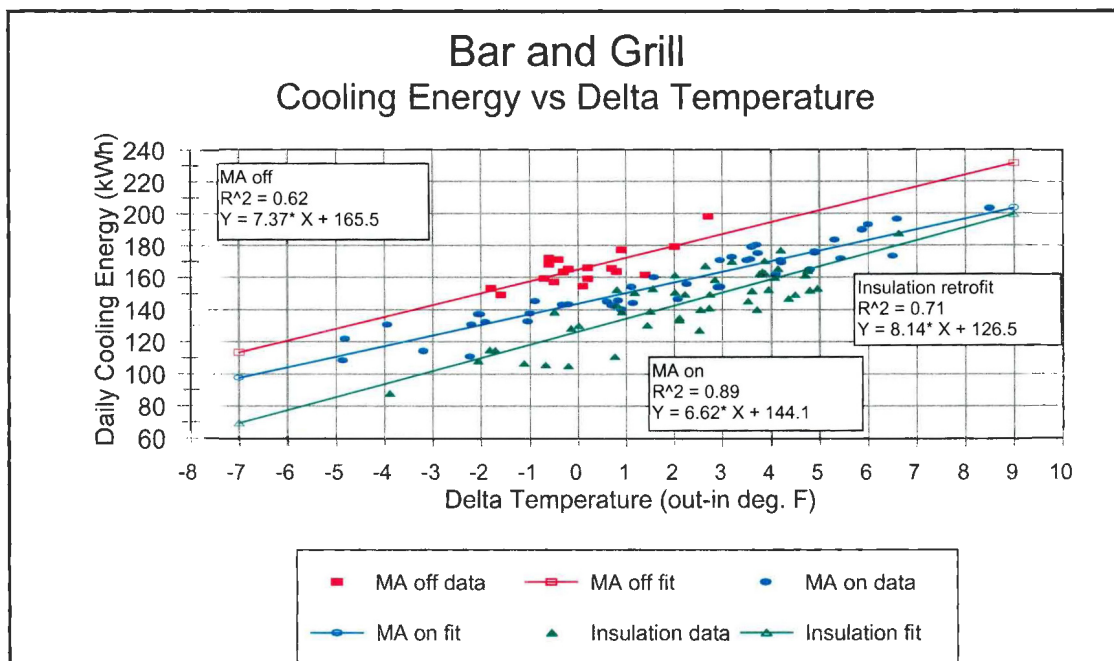
Cooling energy analysis was performed in a manner similar to that described in the MA energy savings section. Note that the “MA on” line in Figure 5 represents only cooling energy use and does not include MA fan energy use. Cooling energy savings for an eight month season are summarized in Table 7. This analysis includes Sundays since the air conditioning is controlled by thermostats at fixed settings 24 hours a day 7 days a week. This explains why the pre-insulation “MA on” energy use for 8 months (Table 7) is higher than in the “MA on” energy use shown in Table 5. During pre and post insulation monitoring, the MA unit was operated simultaneously with the exhaust fan throughout both monitoring periods.

**Figure 5** Cooling energy used before and after MA and insulation retrofits

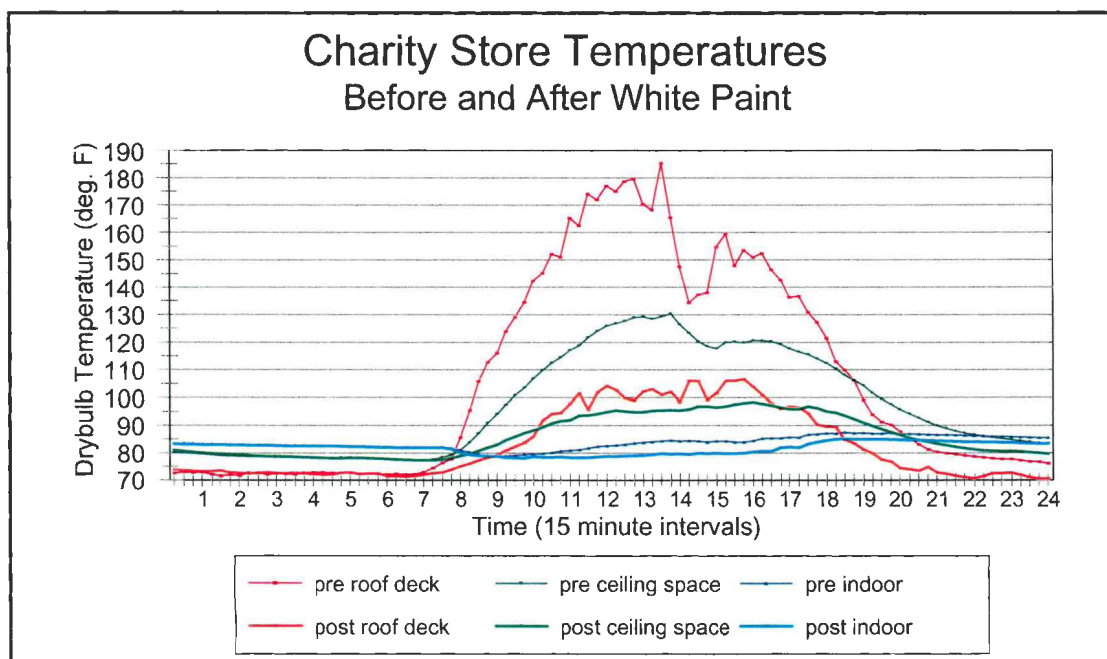
Figure 6 compares temperatures before and after the exterior walls and roof were painted white. Days with similar outdoor temperature, relative humidity, solar energy as well as similar indoor operating conditions were chosen for the comparison. The sharp dip and rise in the roof deck temperature before paint was applied shows the rapid response of the unpainted corrugated metal roof has to sunlight. When the solar radiation upon the roof would change significantly, such as from very sunny to very cloudy, the roof deck temperature could be observed to drop every 10 seconds as data was collected by the datalogger.

**Figure 6** Charity thrift store temperatures for one day before and one day after the building was painted white.

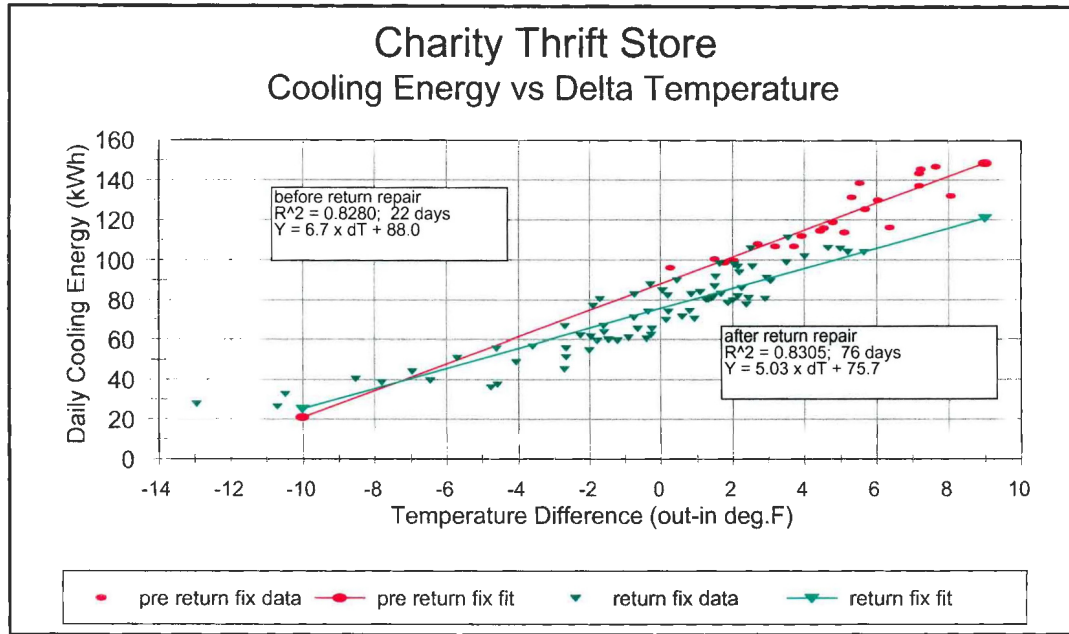
Analysis of cooling energy consumption data predicts cooling energy savings of 14.8% as a result of this retrofit for a typical 8 month cooling season. Figure 7 shows the building cooling energy use impacts of the return balance retrofit on the 2.5-ton AC unit.

**Figure 7** Cooling energy before and after return air balance repair to 2.5 ton unit

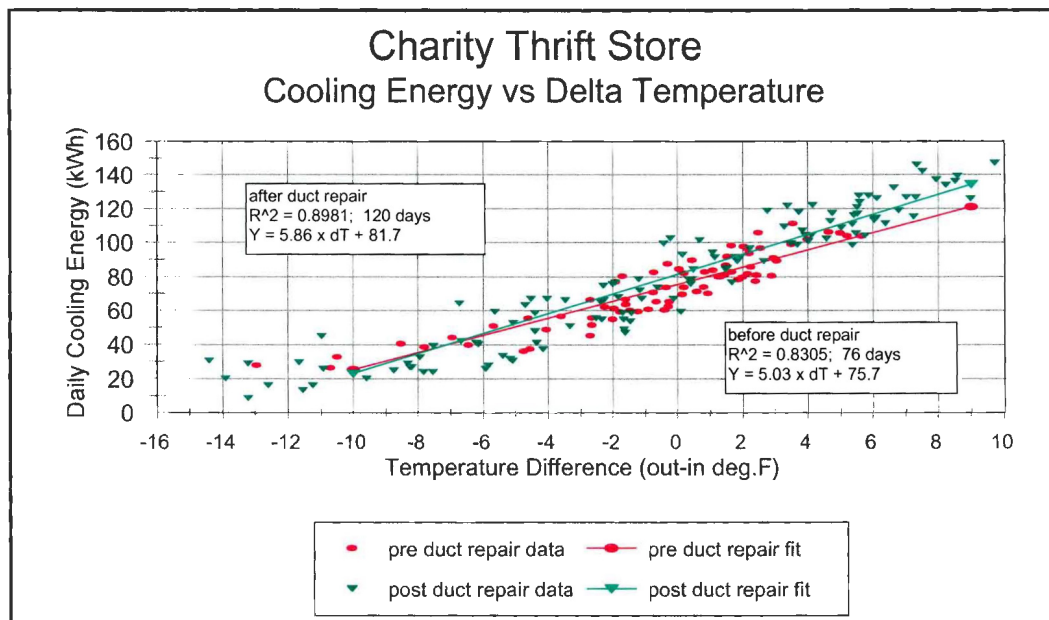
The last retrofit, sealing of duct leaks, was implemented on May 13, 1999. Data collected before and after duct repair shows no energy savings, and in fact shows energy use 8.5% higher after duct repair (Figure 8). If there had been little or no savings, this would not have been a large surprise because relatively little of the total leakage was repaired. As indicated earlier much of the leakage was at flexible duct connections. These connections were originally sealed with fabric duct tape that was wound very tight around the outer thermal liner at the connection collar. This tape was found to be in reasonably good shape and the several windings at each connection were very tight and not easy to remove on several of the connections. When the tape was removed and the outer liner was pulled back to expose the inner liner, the inner duct would start to unravel as it was disturbed. It was made up of a very thin cellophane type of material 2-1/4 inches wide that was spiral wound. After

encountering problems with the inner liner coming apart at four connections, it was decided to apply mastic around the outer jacket of flex duct connections. This would not eliminate any leakage from the inner duct to the outside jacket. There were also several air flow dampers on the branch ducts that were leaky. The dampers were constructed of light sheet metal and had the appearance of poor quality fit and finish. These could not be sealed (with mastic) completely without making the damper inoperable. Mastic would seal the damper in place but it would become inoperable in the future.

**Figure 8** Cooling energy used before and after duct repairs.

The fact that energy use actually increased by 8.5% after duct repair is certainly a surprising finding considering that some duct leakage was repaired. At worst one would expect no increase in energy use. There are two factors, however, which may account for the increased energy use. First, the temperature of the roof deck and ceiling space is about 1 degree Fahrenheit higher after repair (Table 16). Second, and more importantly, outdoor dew-point temperature (as measured by our outdoor temperature/relative humidity monitor) increased substantially from 61.5 F to 69 F from before to after duct repair. Because of the much higher outdoor dew-point temperature, the latent load associated with air infiltration would be much higher during the post-repair period.

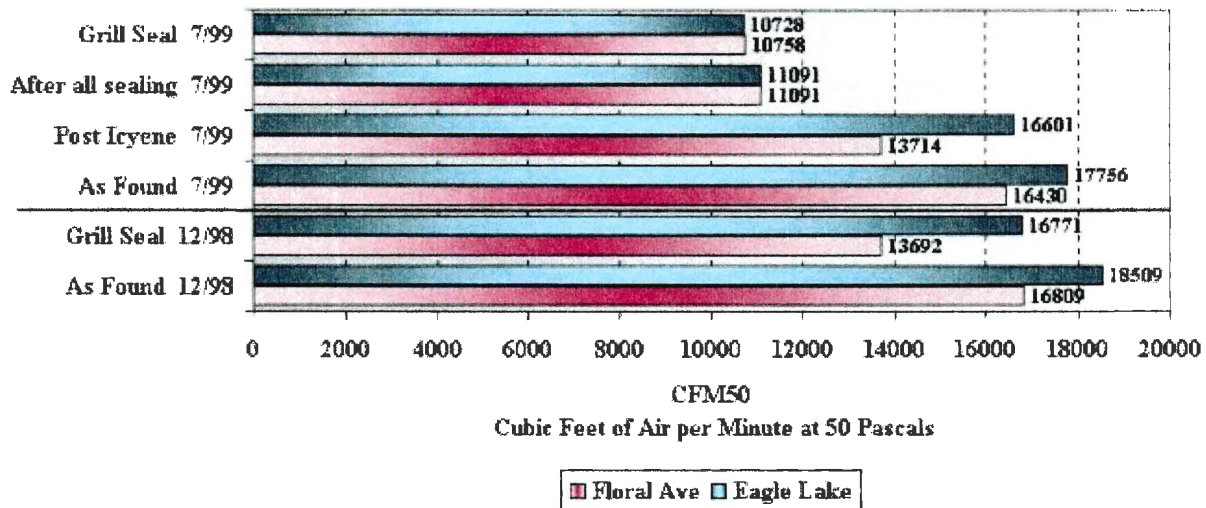
Building airtightness testing was repeated after the retrofits were completed. The airtightness of Floral Avenue was reduced from a CFM50 of 16430 to 11091 (32.5 % reduction) and Eagle Lake was reduced from CFM50 of 17756 to 11091 (37.5 % reduction). Figure 20 shows the results of various air tightness tests at the two monitored school buildings.

**Figure 20** Airtightness results through the stages of retrofit of the metal framed buildings.

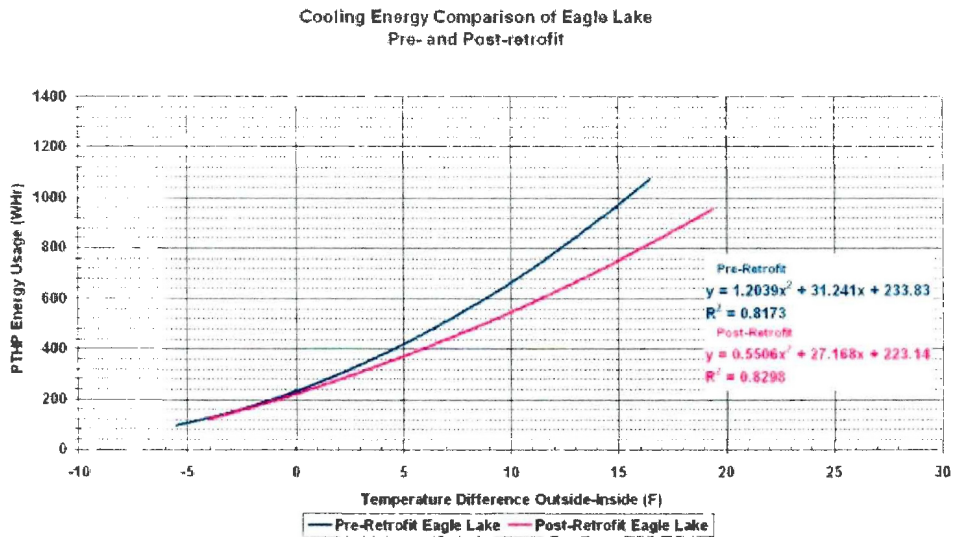
**Figure 21** Eagle Lake air conditioning hourly energy use comparison

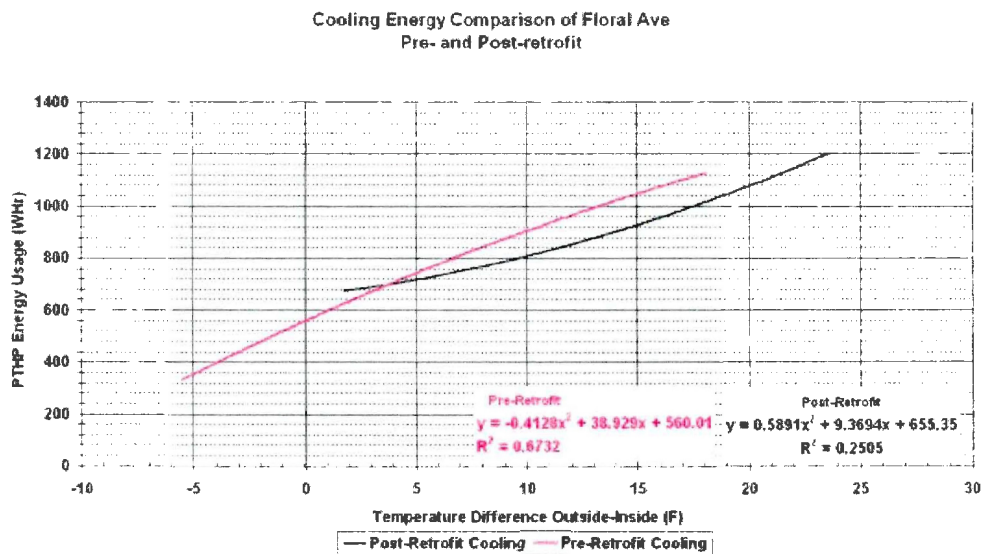
**Figure 22** Floral Ave air conditioning hourly energy use consumption
