Unbalanced Return Air in Commercial Buildings

Charles R. Withers, Jr. and James B. Cummings

Florida Solar Energy Center (FSEC)

FSEC-RR-139-06

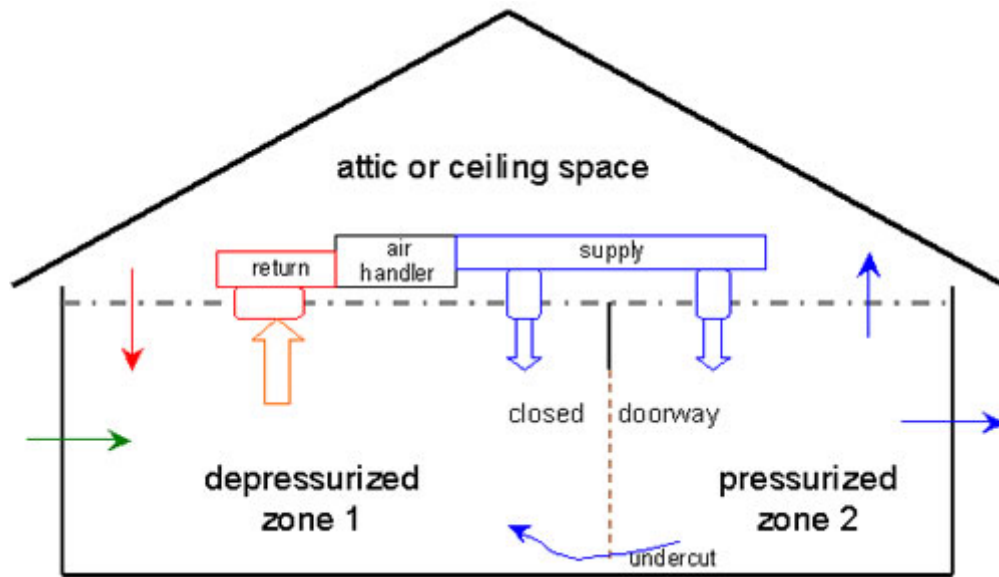
In the first case, return air can be restricted when an air distribution system has a centrally located return with supply air dropped into rooms with doors as shown in Figure 1. The closed room becomes pressurized and the central zone, where the return is located, becomes depressurized. The positive pressure pushes air out of the building, some through door, window, and wall assemblies, but the greater amount will move directly through the tile ceiling into the ceiling space. Likewise, in the central zone, negative pressure will pull some air into the building through doors, windows, and wall assemblies, but most will enter through the suspended T-bar ceiling.

Figure 1: Air Flow and Pressure Impacts from Closed Doors With Central Return

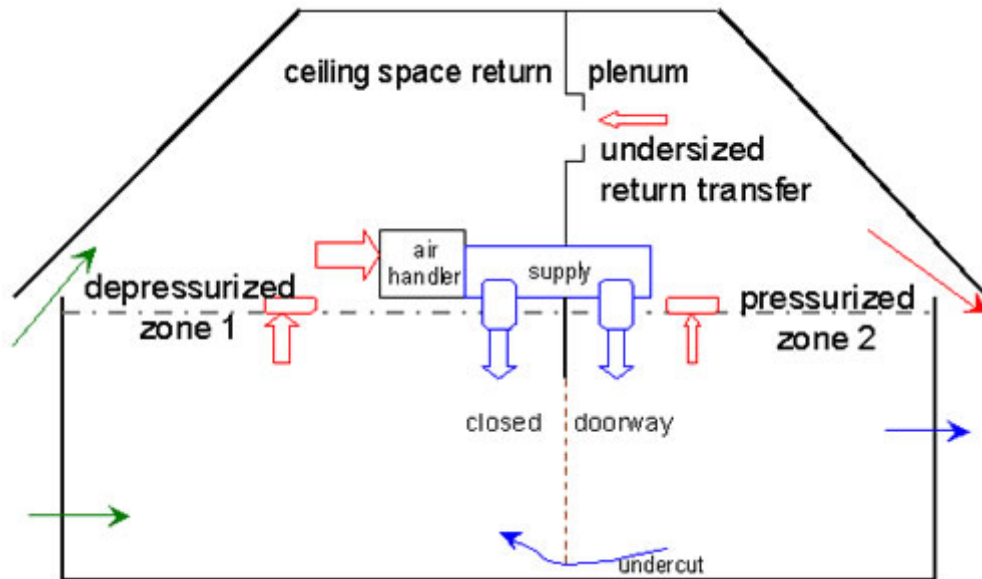
In the case of fire walls subdividing a ceiling space used as a return plenum, return air may be restricted when transfers are undersized (as shown in Figure 2). When the door to zone 2 is closed, air from that zone travels into the ceiling space, then through a transfer opening in the fire wall. If the fire wall transfer is too small, all of zone 2, including the ceiling space of zone 2, will be under positive pressure, while the occupied space and ceiling space associated with Zone 1 will be depressurized. The positive pressure in zone 2 will cause exfiltration to outdoors and the negative pressure in zone 1 will cause infiltration from outdoors.

Figure 2: Ceiling Space Return Plenum With Undersized Return Transfer

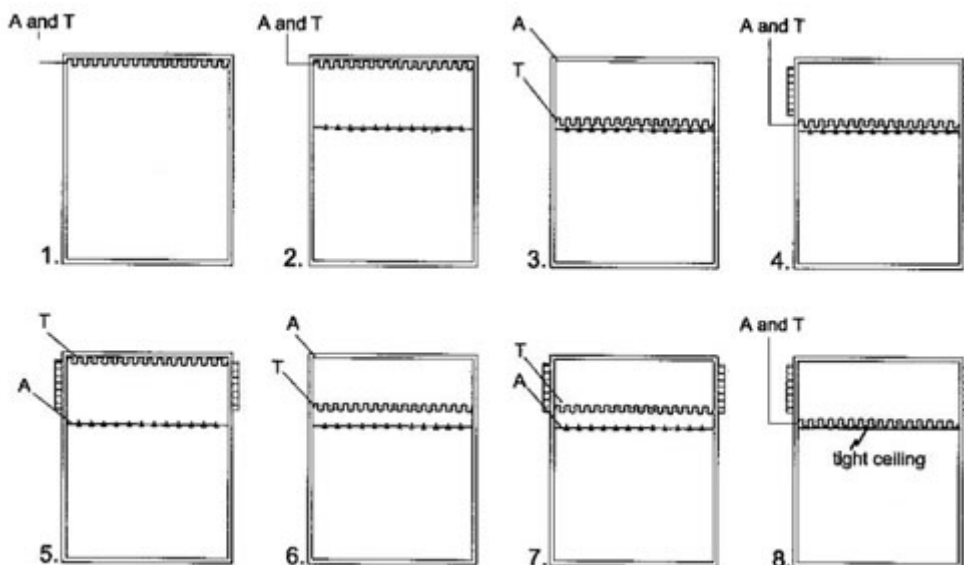
Temperature and humidity conditions in the ceiling space are affected by the location of air and thermal barriers. Figure 3 shows eight types of ceiling spaces identified in Florida buildings that may help explain why some buildings experience greater impacts from unbalanced air than others. The letter "A" represents the primary air barrier location and "T" represents the primary thermal barrier location. Note that a primary barrier (either air or thermal) does not mean this barrier performs well, only that it performs more effectively than the other components of the building assembly. For

Ceiling space type 1 has no ceiling and the roof deck can be seen from the floor. This type is common in large retail and some restaurants and theatres. Ceiling space types 2-7 have suspended acoustical tile ceilings. Type 2 is similar to type 1, except for the lay-in ceiling. Since suspended tile ceilings are leaky, the ceiling space is not vented, and the insulation is at the roof, the primary air and thermal barriers are located at the roof. During summer weather, this ceiling space is warm and dry. Type 3 is similar to type 2 except that insulation is at the ceiling (typically batt insulation on top of the ceiling tiles). During summer weather, this ceiling space is hot and dry. Type 4 is an intentionally vented type 3. Because the vents make the ceiling space leakier to outside, the ceiling is typically the primary air boundary because it resists airflow better than the ceiling space envelope. During summer weather, this ceiling space is hot and humid. Type 5 ceiling space is an unusual configuration, with vented ceiling space and insulation at the roof deck. During summer weather, this ceiling space is warm to hot and humid. Types 6 and 7 would be found in buildings with wood roof truss construction when batt insulation is stapled to the bottom of the trusses some distance above the ceiling. During summer weather, these ceiling space configurations will be hot and dry and hot and humid, respectively, though temperatures will be substantially higher above the insulation level. Type 8 has gypsum board ceiling construction (or other comparable tight construction). This is similar to single-family residential units and results in a much tighter conditioned space.

Figure 3: Eight Ceiling Spaces Based on Air and Thermal Barrier Location

Types 1 and 2 would be the best construction (most forgiving) if unbalanced return air or duct leakage exists. This is because air transferred across the ceiling plane will be more similar to conditioned space than outdoors. Type 4 would be the worst type since the air transferred across the ceiling will be hot and humid during hot and humid summer weather and cold and dry during winter weather. The most common ceiling space in Florida is type 4, with 29% of 70 commercial buildings studied having this type, while only 37% had the more benign ceiling spaces of type 1 and type 2 (Cummings et al. 1996).

This study involves a 149,000 ft² (13,842 m²) building spread over five stories. The first four floors have separate zones with a common central atrium. The fifth floor was isolated from the lower floors. The building has a type 2 ceiling space (Figure 3) that was used as a return plenum. Fortunately this type of ceiling minimizes any energy-associated penalties from uncontrolled air flows. The building was very air tight as determined by door fan pressurization testing. CFM50 was found to be 42,034 (19.8 m³/s). This can also be expressed as 1.17 ACH50, indicating that this is a very tight building. The average of 69 other small commercial buildings in Florida was 16.7 ACH50 (Cummings et al. 1996).

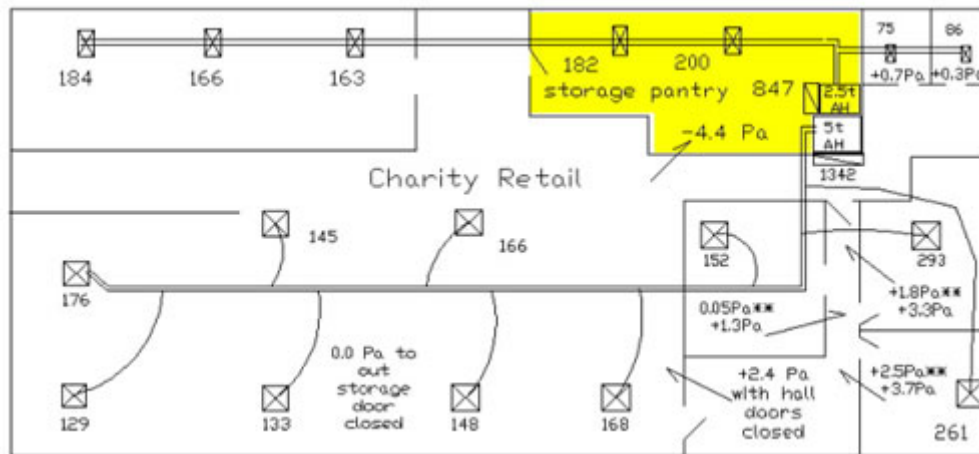
Figure 4 shows ADS layout, supply and return airflow as well as zone pressures in Pascals with interior doors closed. Zone pressures are measured with both air handlers on with reference to (wrt) the central building zone unless noted otherwise. There was no notable pressure difference in the main body with reference to outside. Register flows are in cubic feet per minute.

Figure 4:
Floorplan With Grille Flows (cfm) and Room Pressure (Pa) Across Closed Doors

** pressure in room wrt hall with hall door closed.

Return air for the 2.5-ton system was located entirely in the storage pantry room shown as a shaded area at the top of Figure 4. Measured airflow through the grille was 847 cfm (399.7 l/s) with approximately 50 cfm (23.6 l/s) in return leakage from the room into the air handler. This room has two doors that are often closed for security reasons. When closed, they cause room depressurization of -4.4 pascals (-0.0177 in w.g.). Observation of the air flow balance in this room illustrates the uncontrolled return air problem. Two supply grilles deliver a combined 382 cfm (180.3 l/s) into the room. (However, supply air measurements on these supply registers overestimate flow – see discussion in following paragraph.) We estimate supply air to be 306 cfm (144.4 l/s). A transfer grille in one door and minor door undercuts allow about 250 cfm (118.0 l/s) to pass into the room. The remaining air flow into the room, of about 341 cfm (160.9 l/s) (38%), is drawn from the hot ceiling space through the ceiling. Simultaneously, room air from the main zone of the building is pushed into the ceiling space.

Return air for the 5-ton system is located entirely in the central hallway. An office suite, containing three offices and a central foyer can be closed off from the retail area shown on the right side of Figure 4. Since there is no return air to this suite, it operates at positive pressure when the suite door is closed. Individual offices within the suite operate at positive pressure even if the suite door is open. This positive pressure pushes air through the ceiling, and air is then drawn from the ceiling space into the central hallway area in order to return to the return grille.

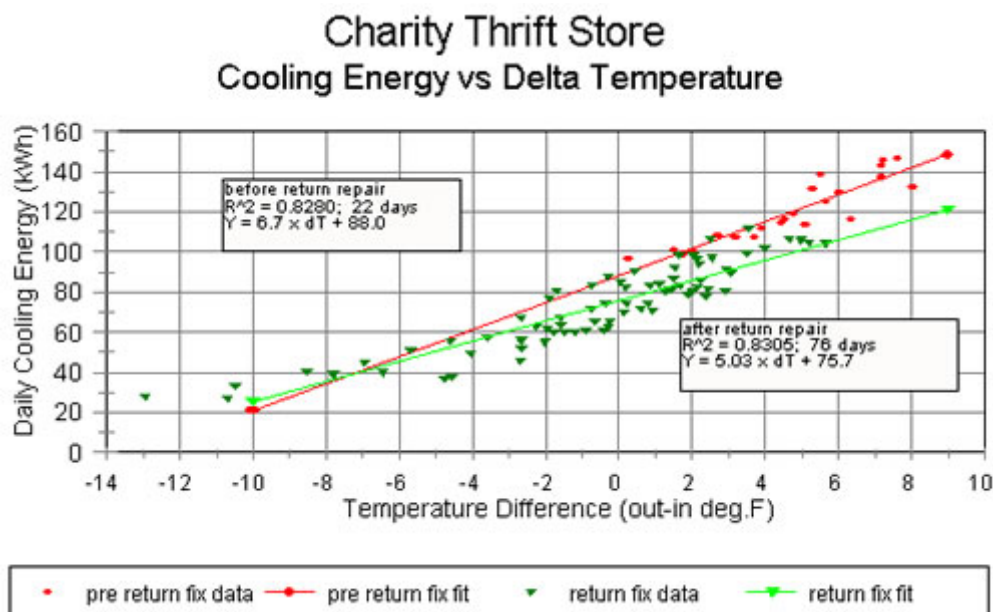
Cooling energy use was monitored for a period of 6 months, however only 22 days of pre-repair data were available and much of the post repair data was not used over winter months due to minimal cooling required. Cooling energy use as a function of the temperature difference between outdoors and indoors was used to develop a linear regression. The linear regression was used to predict cooling energy savings. Developing the linear regression involved three steps. First, monitoring data was screened so that only comparable days were used. Comparability was based on similar outdoor dry bulb temperature, outdoor dew point temperature, solar radiation, wind, rain, door closure, and thermostat settings. Second, 24-hour total cooling kWh electricity consumption was plotted against the 24-hour average temperature difference between outside and inside. Plotting against the temperature difference helped to account for changes indoors such as t-stat setting changes (business and non-business hours settings). Third, a least-squares best-fit linear regression was performed on each series of data. The best-fit line provided the equation used to predict the cooling energy when the temperature difference was known. These results are shown in Figure 5.

Figure 5: Total Cooling Energy Per Day vs Daily Average dT (out-in)

Energy savings for a particular type of day can be calculated directly from the best-fit lines of the regressions. If a day with an outside temperature that represents the average temperature over 8 months is chosen along with an average indoor temperature, then a simple estimate for the average daily savings over 8 months can be obtained. This type of analysis assumes all days over an 8 month period are exactly the same.

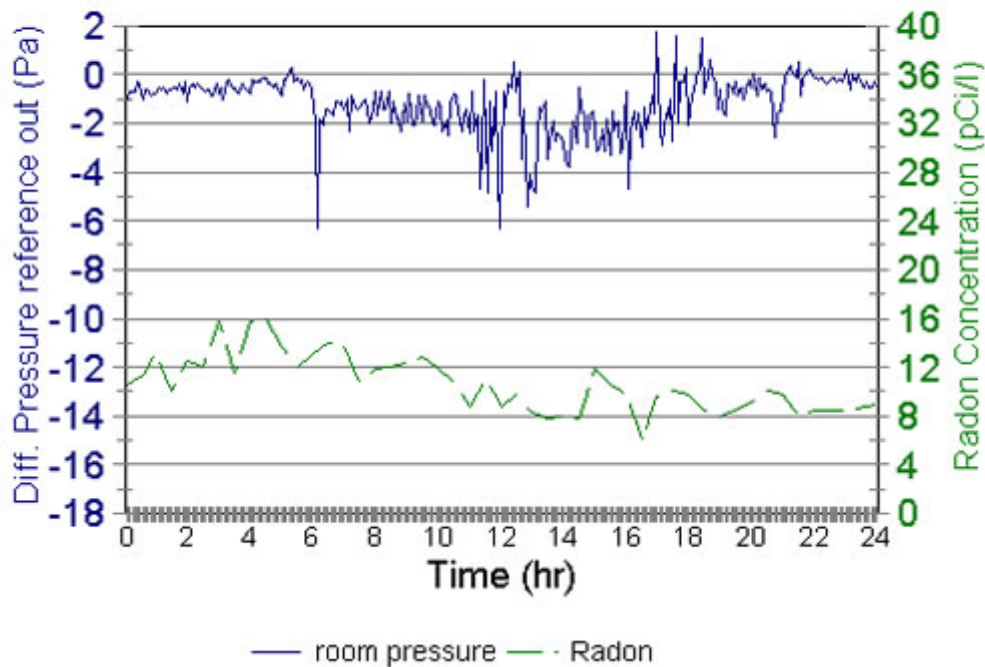
Boardroom Typical Day Room Pressure and Radon

Figure 6 shows typical pressure (with respect to outdoors) and radon levels in one of six first-floor zones during a 24-hour period on a weekday. Note that the pressure in this zone is about 2 Pa (0.0080 in w.g.) more negative during the period from 6 AM to 6 PM, and radon concentrations are always above EPA standards. It is the consistent negative pressure that transports radon gas entry into boardroom. The decrease in concentration as depressurization increases can be explained as a relation of radon entry rate and ventilation dilution rate. Greater cooling load from 6am-6pm results in more ventilation air delivered to indoors. Although greater negative pressure would increase the radon entry rate, increased ventilation delivers a higher fraction of outside ventilation air (presumably without significant level of radon) and causes dilution of radon.

Figure 6: Boardroom Zone Pressure and Radon Levels

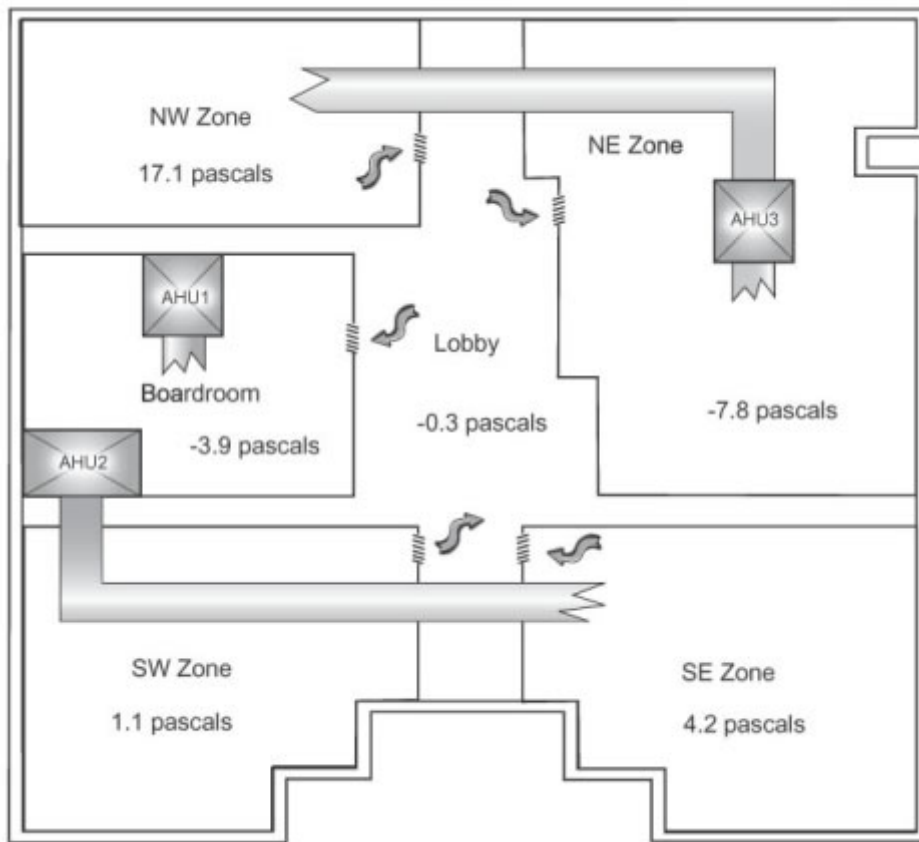
It was found that some first-floor zones were pressurized and others depressurized with reference to outside (Figure 7). The northwest zone, for example, operates at +17.1 Pa (0.0686 in w.g.) while the northeast zone operates at -7.8 Pa (0.0313 in w.g.). The cause of these pressure differentials is unbalanced or restricted return air. There are three air handlers serving the six zones of the first floor. The ceiling space is used as a return plenum. The fire walls that separate the zones intersect the return plenum, creating restriction to return air flow. Return transfer "windows" with fire dampers were provided to allow transfer of return air from one zone to the next. However, these transfers were undersized, in many cases, by a factor of four (Figure 8). In fact one fire damper into the Boardroom had failed in the closed position. Figure 8 shows the "as found" size of the transfer windows and the additional transfer window area required to reduce pressure differential across the fire wall to 2 Pa (0.0080 in w.g.) when the air handlers were at maximum variable air volume setting (VAVmaximum). As of 2003, the Florida Mechanical code requires pressure drops across interior partitions to be no greater than 2.5 Pa (0.0100 in w.g.).

Figure 7: First Floor Plan Showing Return Air Crossover and Zonal Pressures

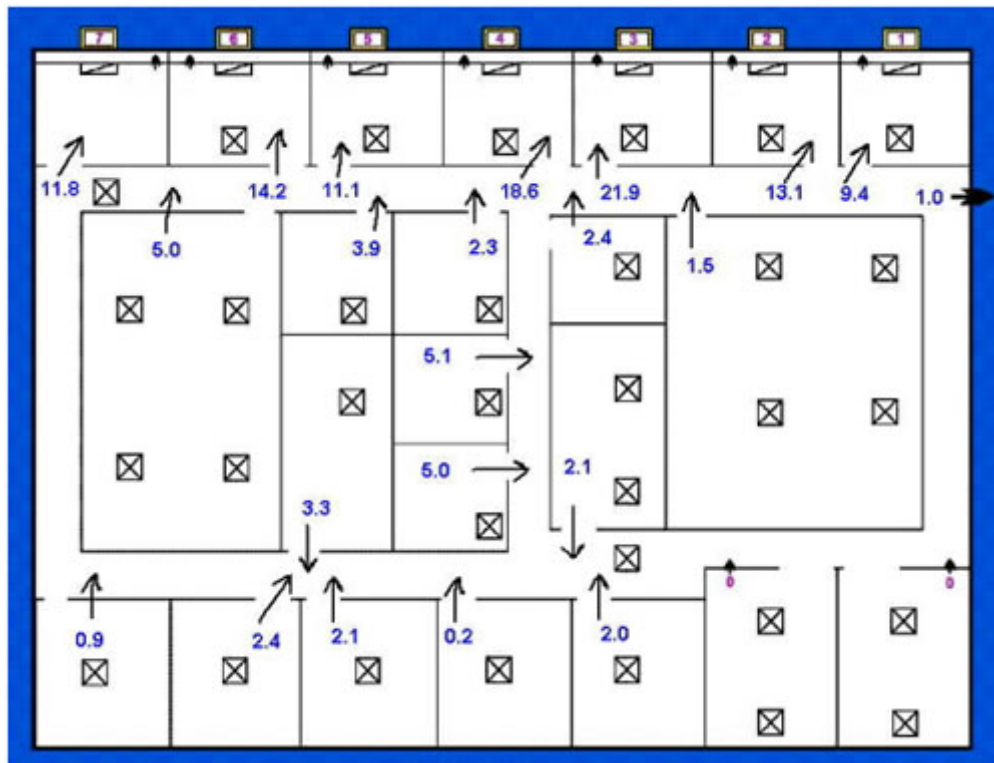
Figure 9 shows a floor plan with the AC units at the top and with pressure measurements taken while office doors were closed. Arrows point from high to low pressure.

Figure 9: Floorplan and Pressure Differentials (Pa) Across Closed Doors

Each AC unit has a single return located in the exterior wall of seven west offices. Supply ducts run through the ceiling space eastward to serve the various spaces. A transfer grille was located in the door of each west office to transfer air when the door is closed. This 9 in x 9 in (0.2286 m x 0.2286 m) grille (with approximate 0.40 net area fraction) is undersized by a factor of 8, under the assumption that 70 square inches (0.0452 m²) of net free area transfer is required for each 100 cfm (47.2 l/s) of return air. The actual free area required depends upon the transfer grille design. The simplest design with a high percentage of net free area would likely need about 70 square inches per 100 cfm. A transfer grille with a lower percentage of net free area may need as much as 100 square inches (0.0645 m²) per 100 cfm. There is a 14.3 Pa (0.0574 in.w.g.) drop in pressure on average from main building to each west office when the office door is closed.

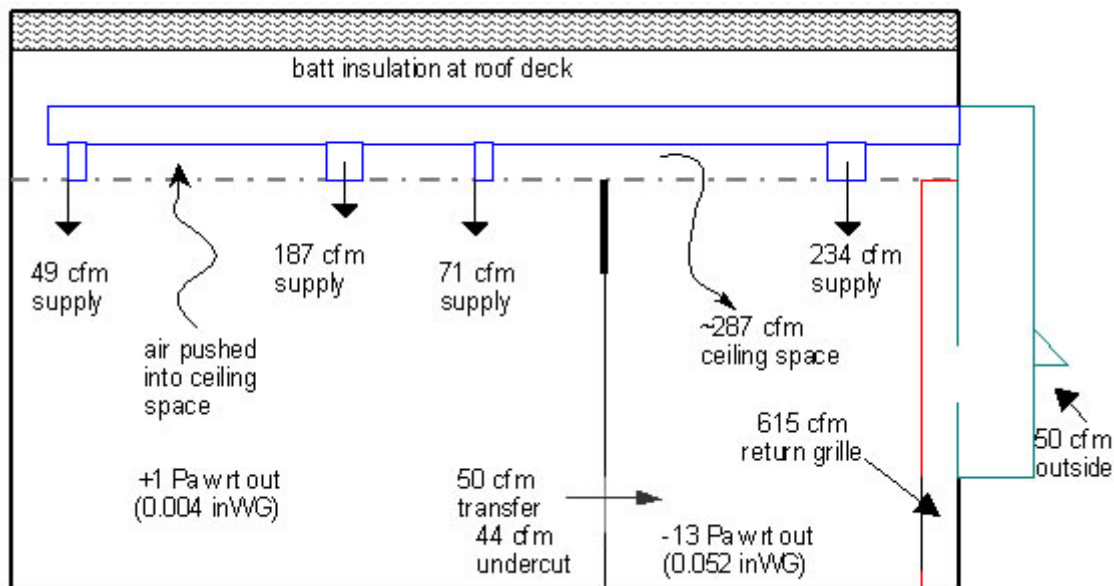
The airflow distribution for a typical unit is shown in Figure 10. The sum of outside air, return leakage, and return grille flow, is 665 cfm (313.8 l/s), while supply grille flows sum to 541 cfm (255.3 l/s). Given flow hood measurement accuracy of +/- 3%, we conclude that the difference of about 120 cfm (56.6 l/s) is primarily due to supply duct leakage (The supply diffusers are 2 ft x 2 ft four-way throw which the flowhood measures reasonably well, unlike single throw diffusers discussed earlier.) Duct leakage testing on this unit measured $Q_{25, total} = 252$ which is quite leaky for this small system. Our $Q_{25, total}$ measurement is based on ASHRAE Standard 152-2004 where the total system leakage in cubic feet per minute is measured using a calibrated fan to depressurize the return and supply ducts to 25 Pa (0.1004 in.w.g.) of pressure. Fortunately the supply leakage is easily "regained" since it is lost into a type 2 ceiling space.

Figure 10: Typical Zone Flow Balance With Office Door Closed Served by AHU#2

The total lack of air balance becomes more obvious when examining the air flow balance on one of the west offices. With the door closed, the following air flows were measured; 234 cfm (110.4 l/s) from the supply, 50 cfm (23.6 l/s) through door transfer, and 44 cfm (20.8 l/s) through door undercut. This only totals 328 cfm (154.8 l/s), which is only 53% of the return grille flow. Based on the premise that the walls and floor are fairly tight, and that the suspended T-bar ceiling is very leaky, we conclude that most of the remaining 287 cfm (135.4 l/s) balance comes from the ceiling space.

The estimate of return air through ceiling tiles was tested by opening one 2 ft x 1 ft (0.61m x 0.30m) ceiling tile in the office. Office pressure changed from -13.0 Pa (-0.0521 in w.g.), to -2.2 Pa (-0.0088 in w.g.), supply air decreased to 216 cfm (101.9 l/s), door transfer went to 39 cfm (18.4 l/s), door undercut went to 34 cfm (16.0 l/s), and return grille flow increased to 656 cfm (309.6 l/s). The expected balance would be 367 cfm (173.2 l/s) through the ceiling when sum of supply air, door transfer and undercut are subtracted from return grille flow. When a flow hood was placed over the open tile, the measurement was 383 cfm (180.8 l/s), or 4% higher than expected for the hole plus remainder of the ceiling.
